***REPORT ON CYCLONE***

***“TRACY”***

**- Effect On Buildings -**

**DECEMBER 1974**

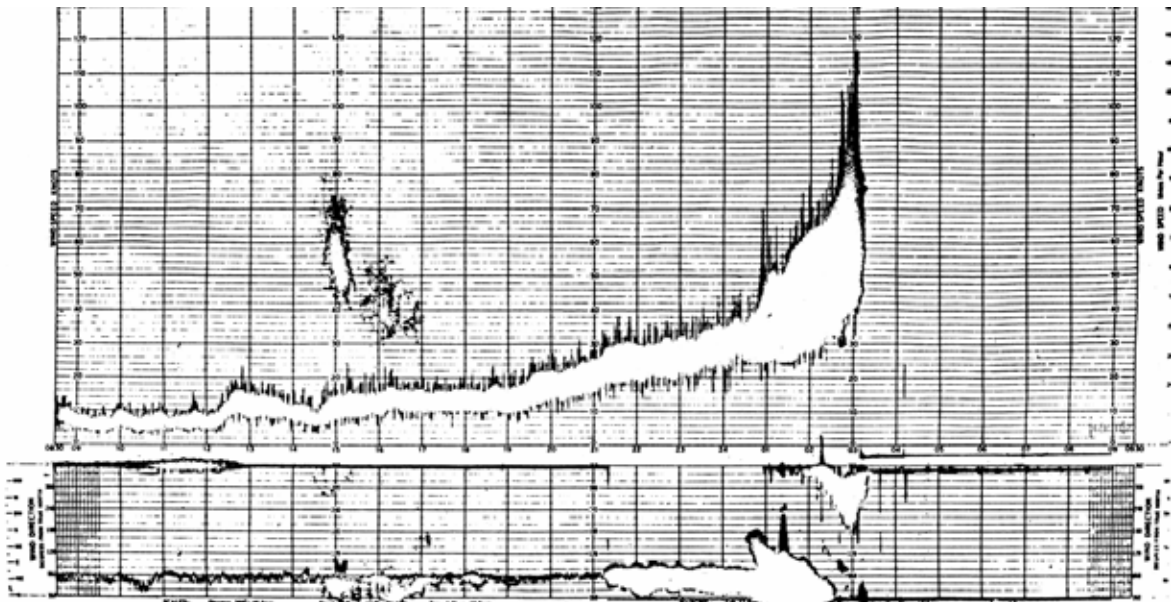
Unfortunately the anemometer operated by the Bureau of Meteorology in Darwin was struck by debris and ceased to function during the passage of the cyclone. This was particularly unfortunate as the anemometer was located in the path of the eye. Figure 3.5 is a copy of the record obtained from the anemometer before it failed.

The time of failure was 3.05 a.m. which would have been shortly before the leading edge of the eye arrived.

The record shows the wind gusting up to 115 knots just prior to the failure, the excursion off the scale being regarded as a malfunction due to the failure.

FIGURE 3.5 ANEMOMETER RECORD FOR DARWIN AERODROME (By courtesy of the Bureau of Meteorology)

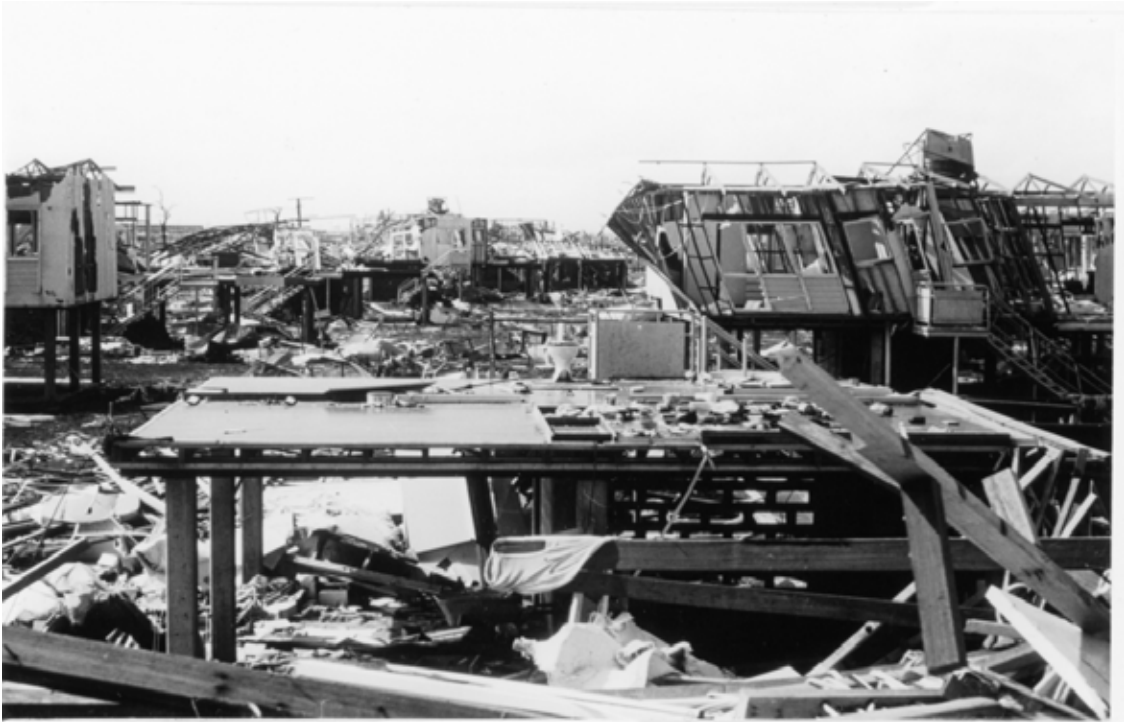
Fig. 4.1 - Severe Damage

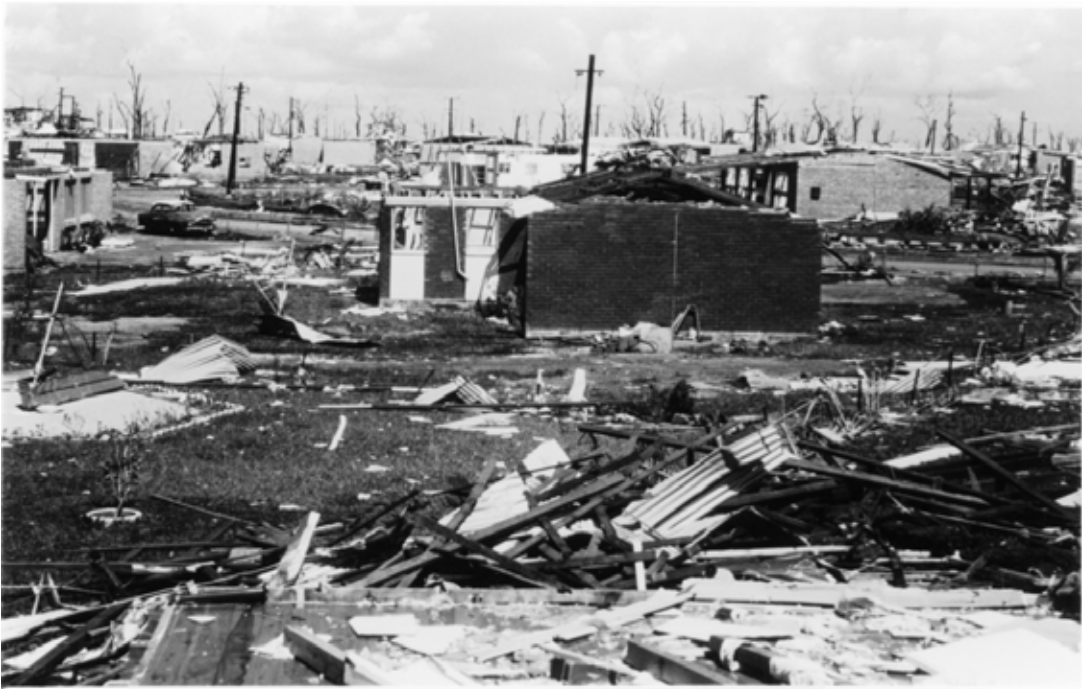
Fig. 4.2 - Severe Damage

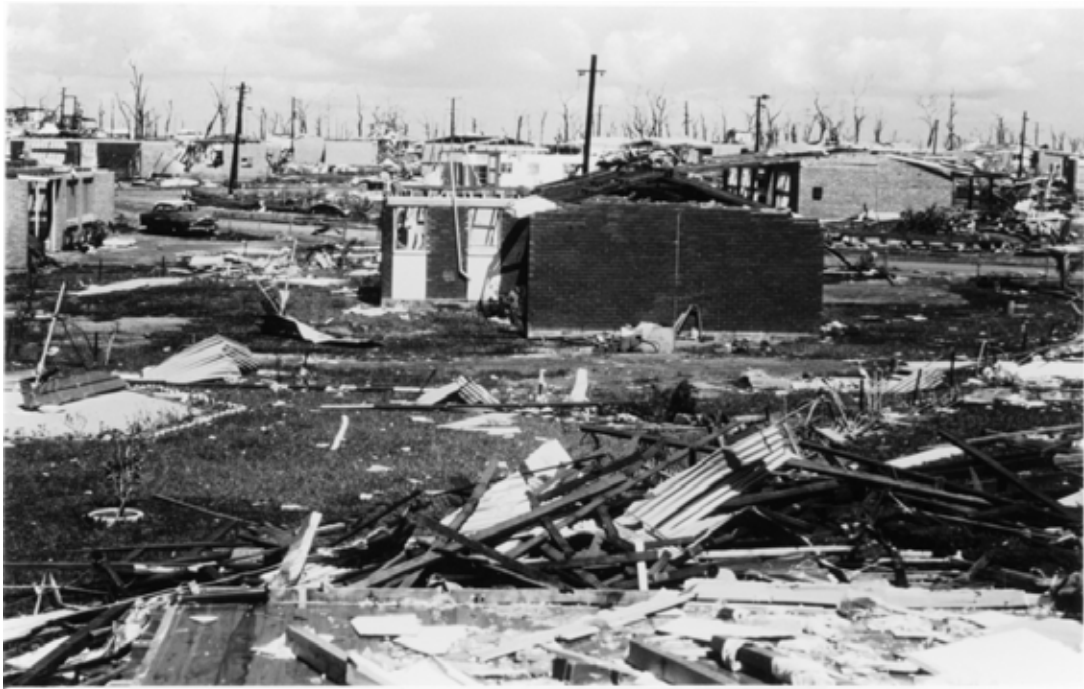
Fig. 4.3 - Moderate Damage

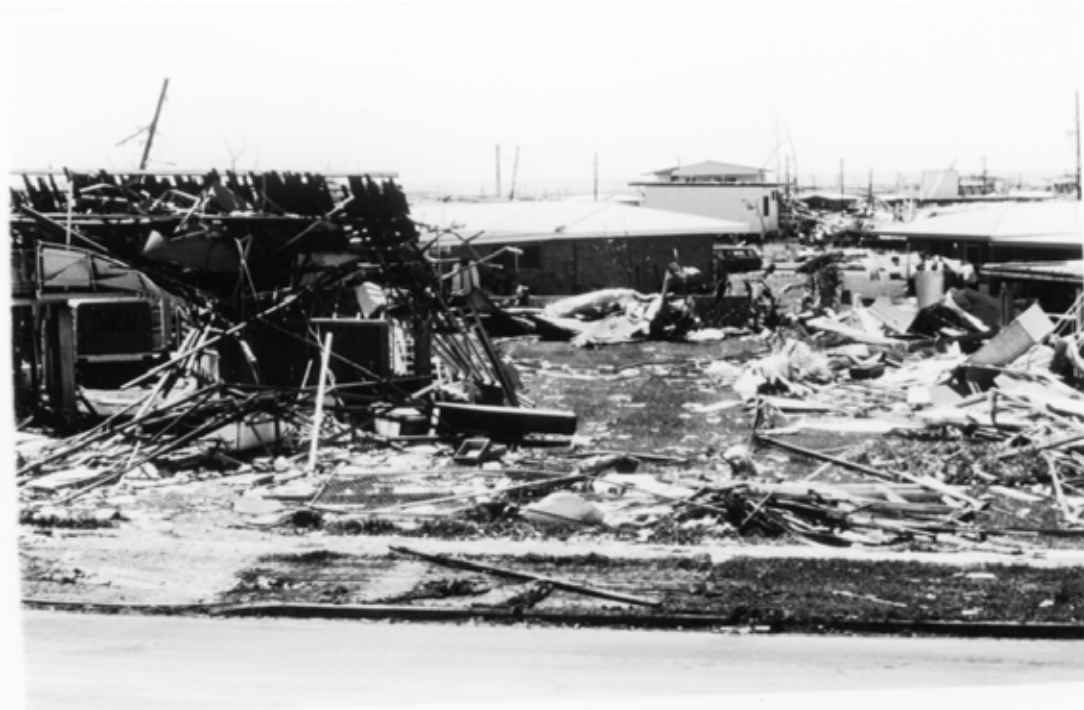
Fig 4.4 - Moderate Damage

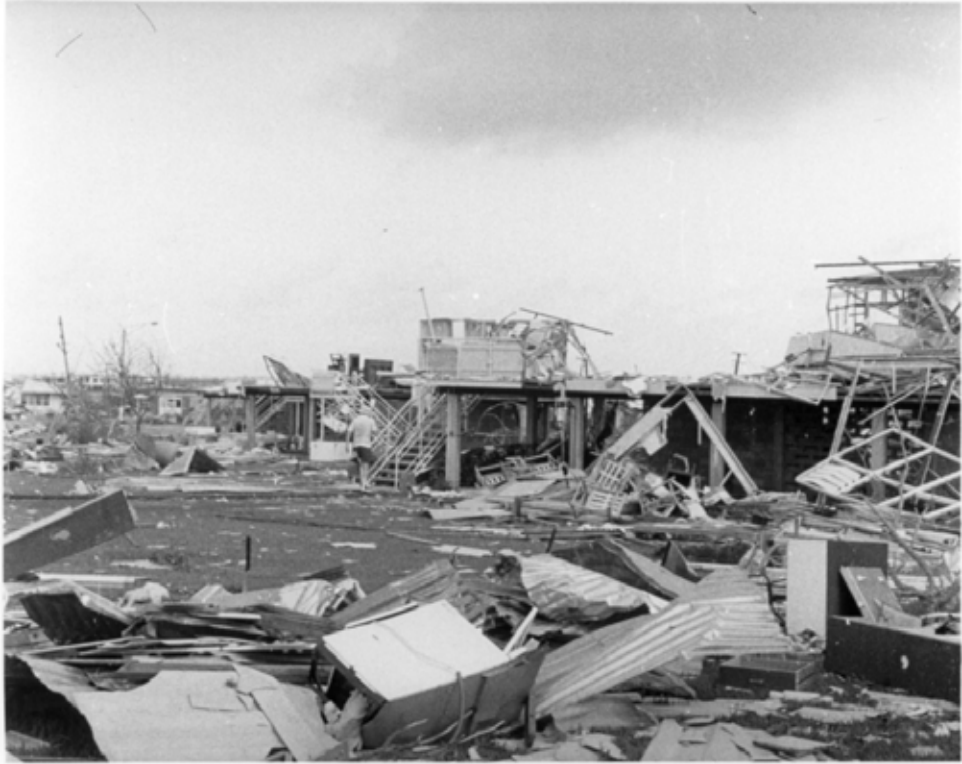
Fig. 4.5 - Debris

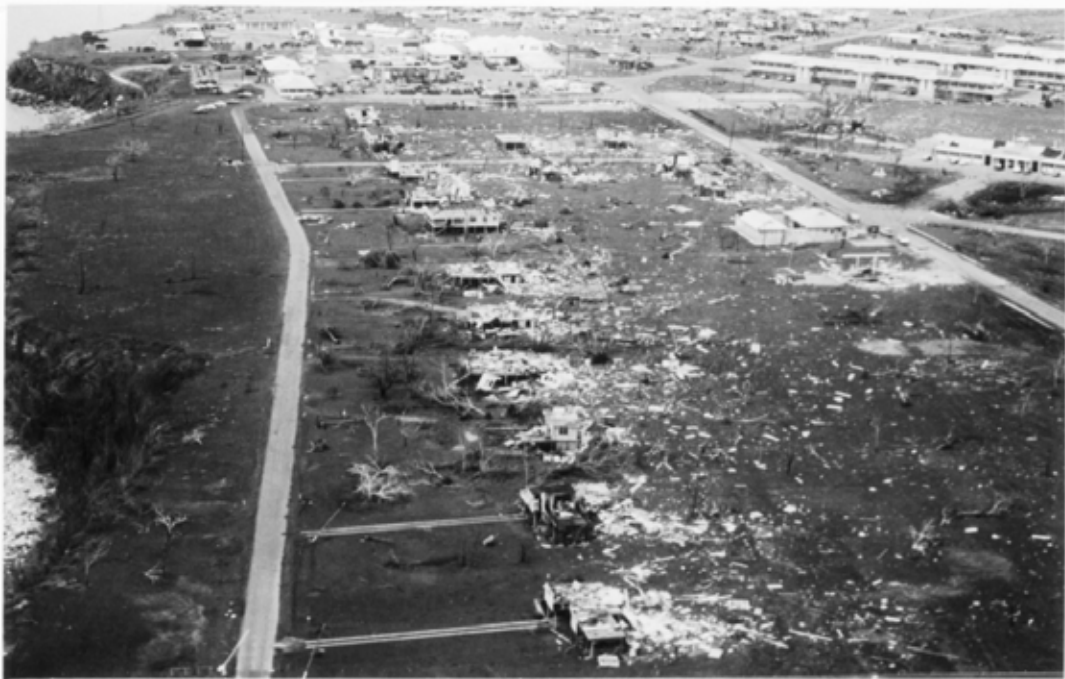
Fig. 4.6 - Exposed Location

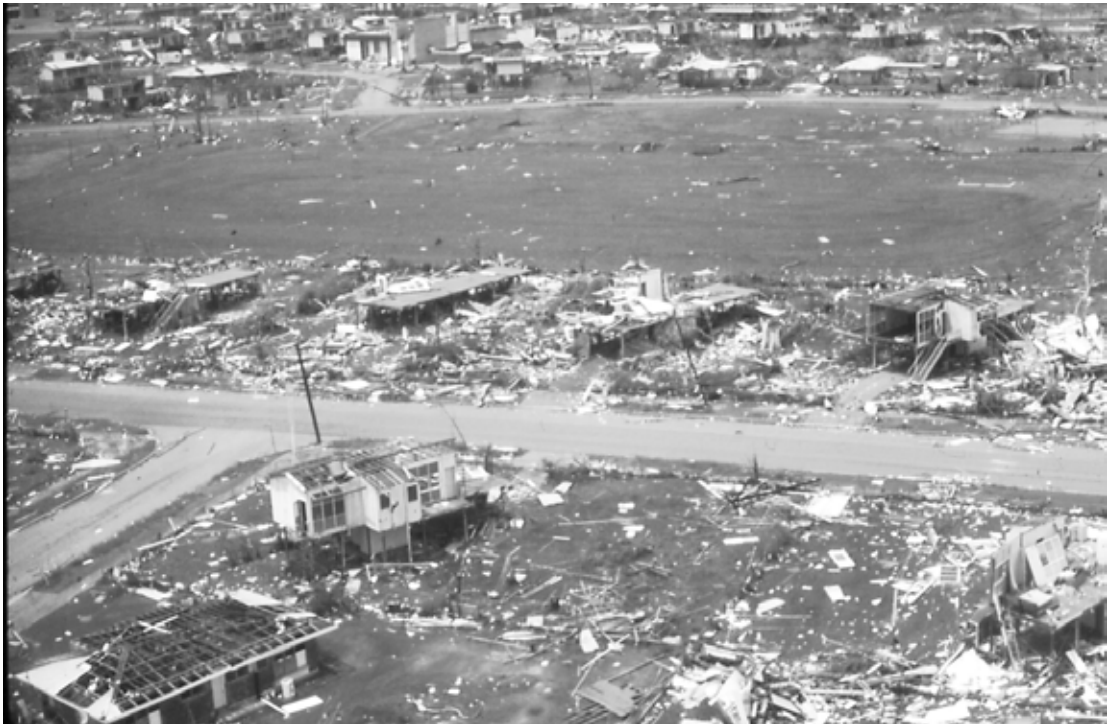
Fig 4.7 - Housing Damage from the Air

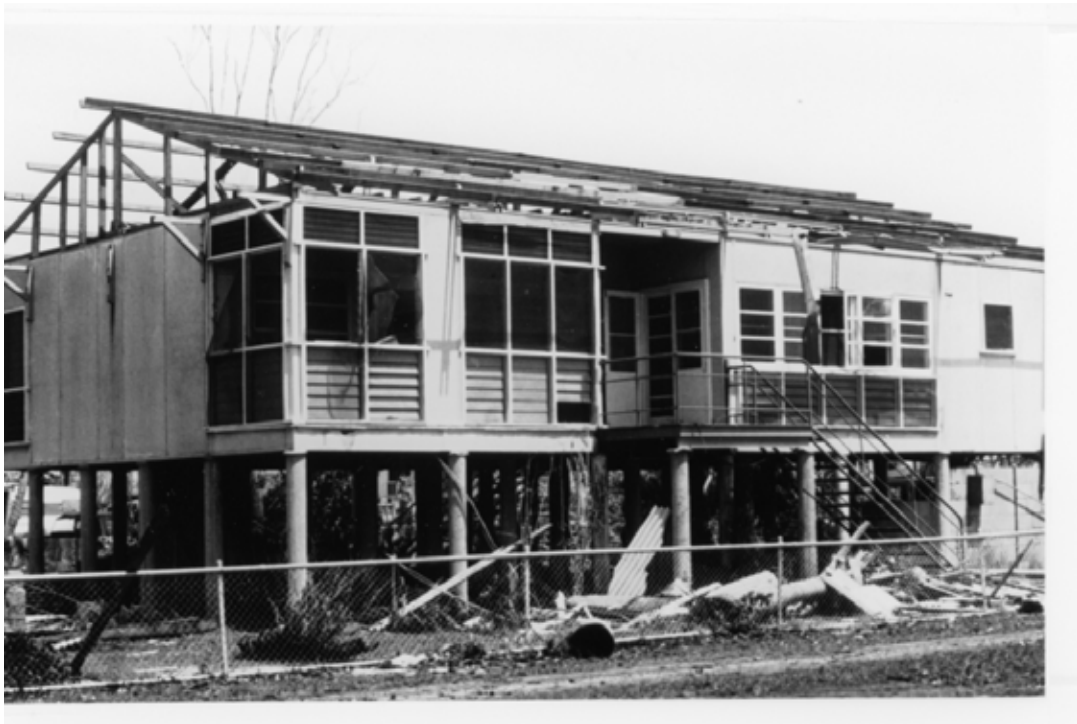
Figure 5.1 shows a typically older style roof failure where sheeting was nailed on to the purlins which were fastened to the rafters with wooden cleats, the rafters being presumably skew nailed to the wall. Here the weakest link was obviously the nailing of the iron and the sheeting has gone with the nails.

Fig. 5.1 - Roof cladding loss – timber cleated purlins

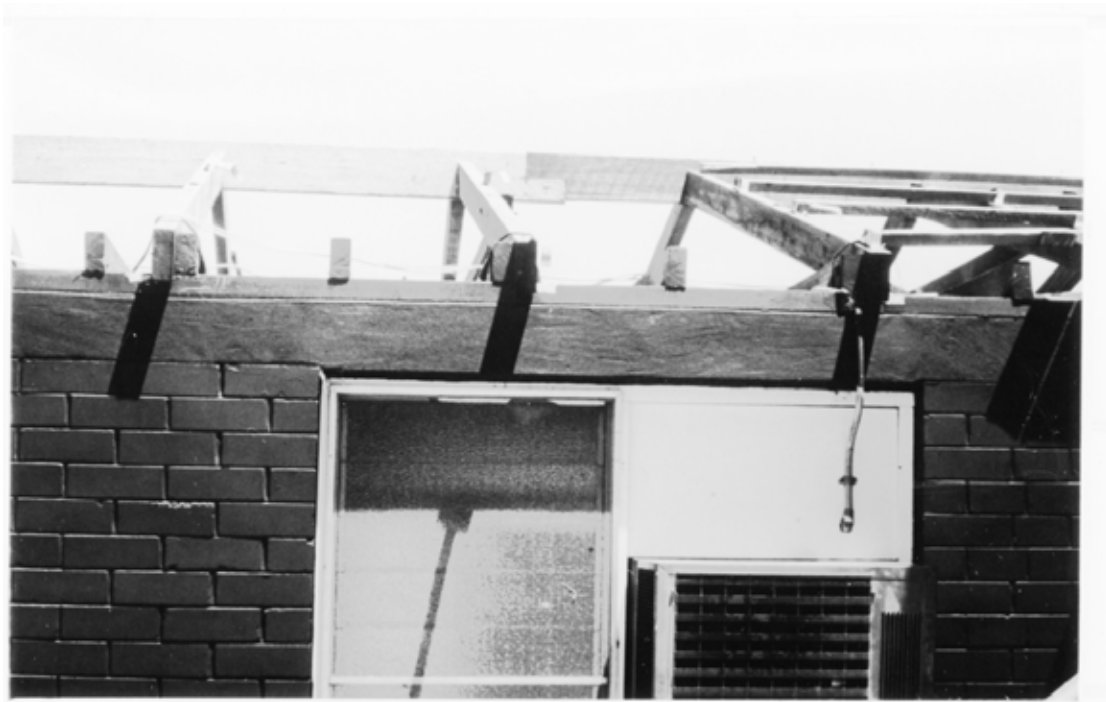
Fig. 5.2 - Roof cladding lost with purlins

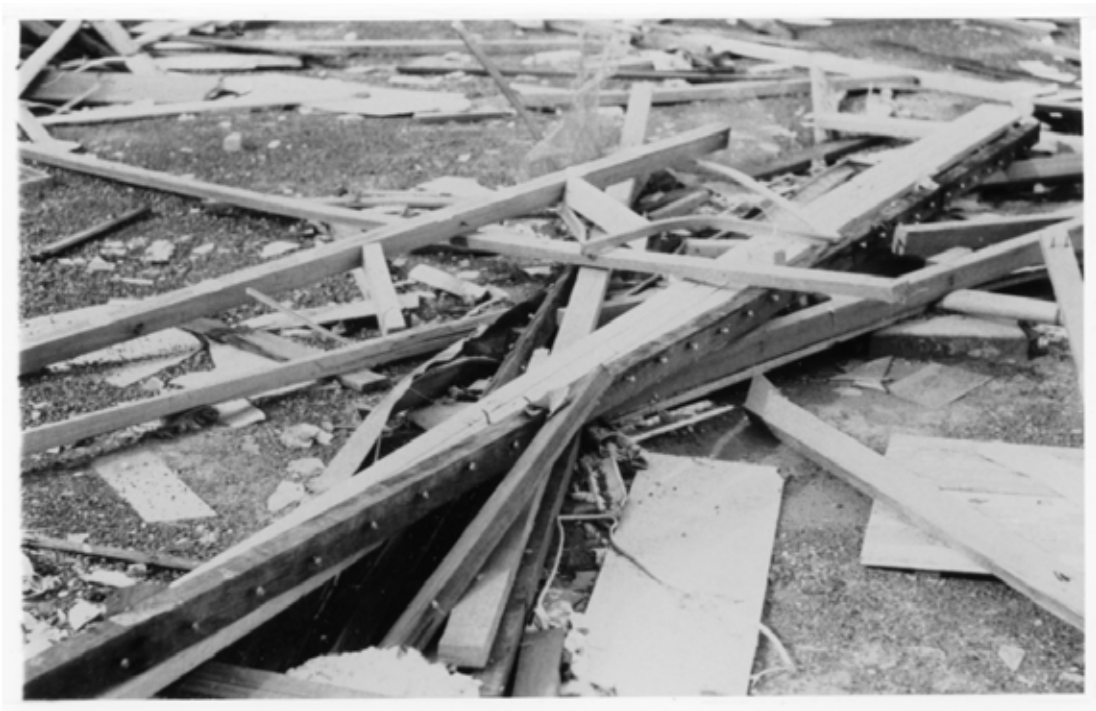
Fig. 5.3 - Screw fastenings remaining in purlin

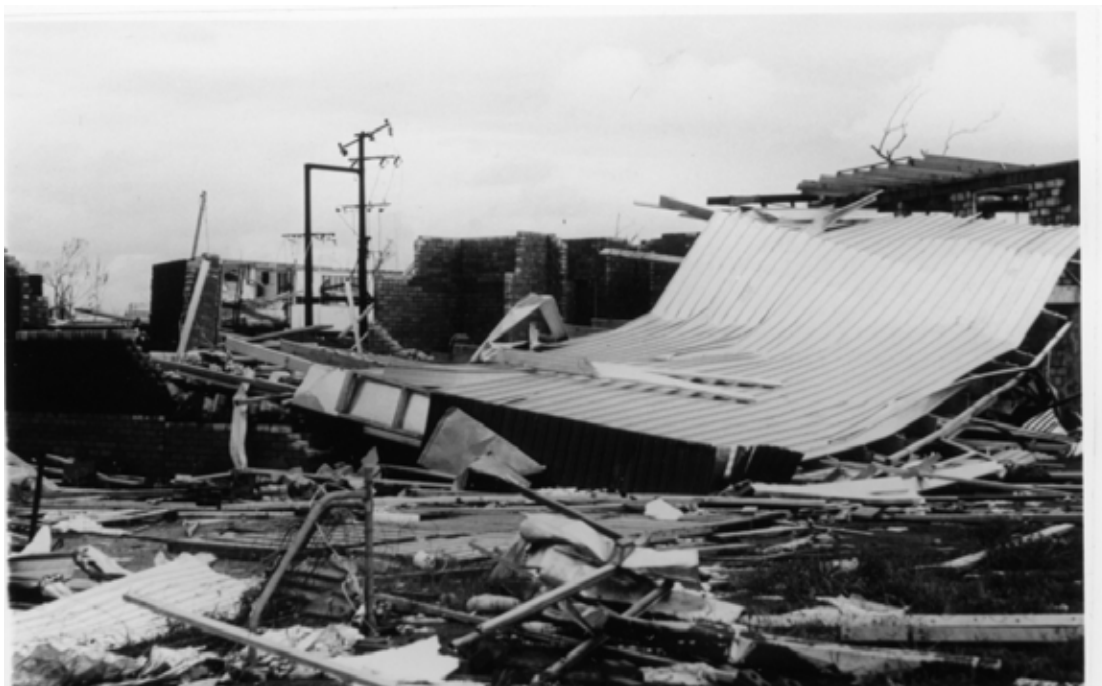
In more recent years spacings of rafters and trusses have become less and particularly since cyclone “Althea” far more attention has been given to the fixing down of the roof, the sheeting being screwed on to the purlins at every second corrugation along the eaves and ends, and every third corrugation elsewhere, and in many cases stronger fixing of purlins to trusses and of trusses to walls and floor have been employed. This construction was to be found in the worst hit suburbs of Nakara, Wanguri and Tiwi. The effect on keeping the roof on of these measures appear to have been negligible with just a change in failure mode occurring. In those structures where the roof structure was well tied down the sheeting pulled off over the screws leaving the screws intact – see figure 5.3 – or where no effective tying down of the roof structure was made the entire roof was lifted off – see figure 5.4. The second of these was more common with low set houses.

Fig. 5.4 - Failure of roof structure as a whole

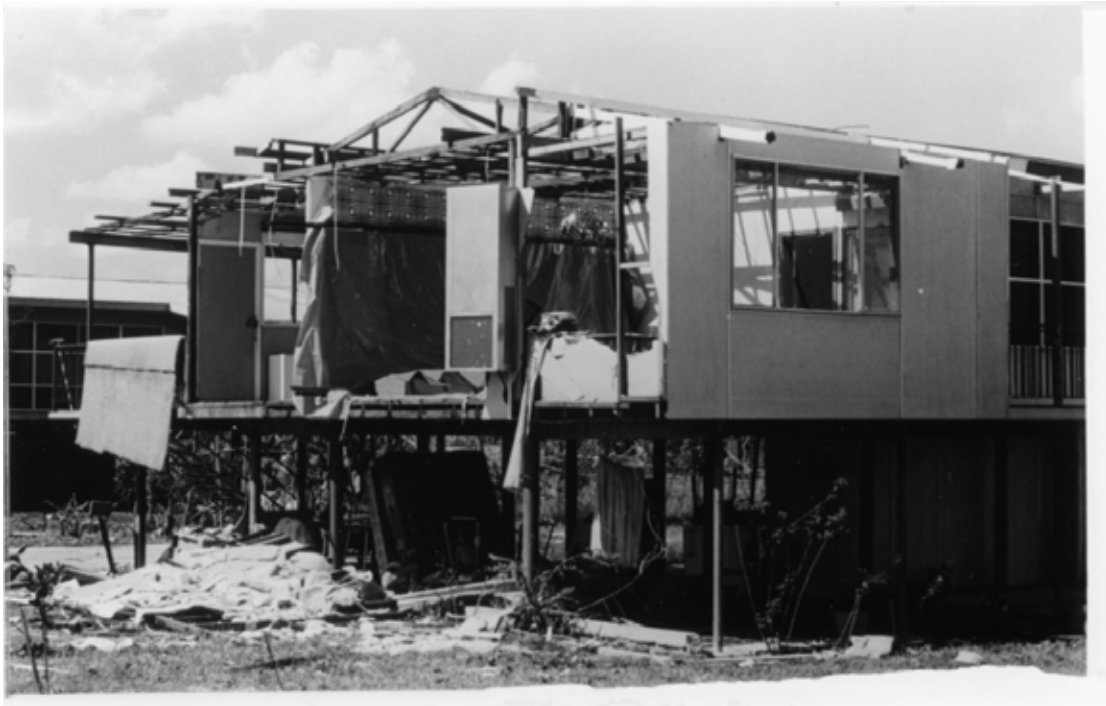
Fig. 5.7 - End wall blown out

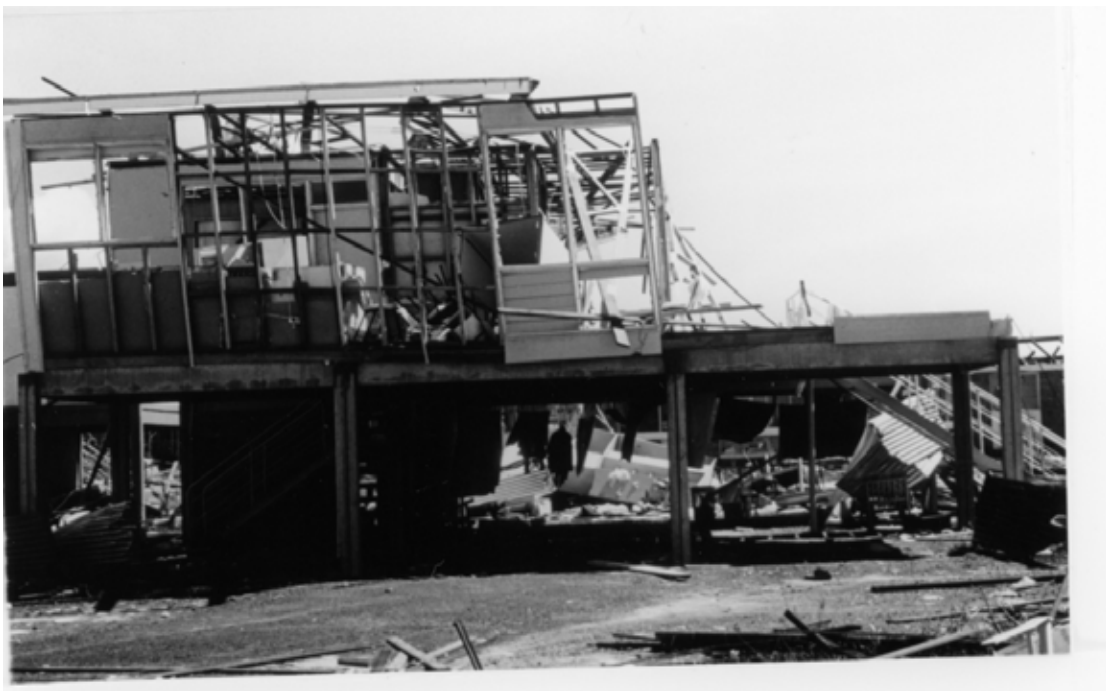
Fig. 5.8 - Typical half demolished house

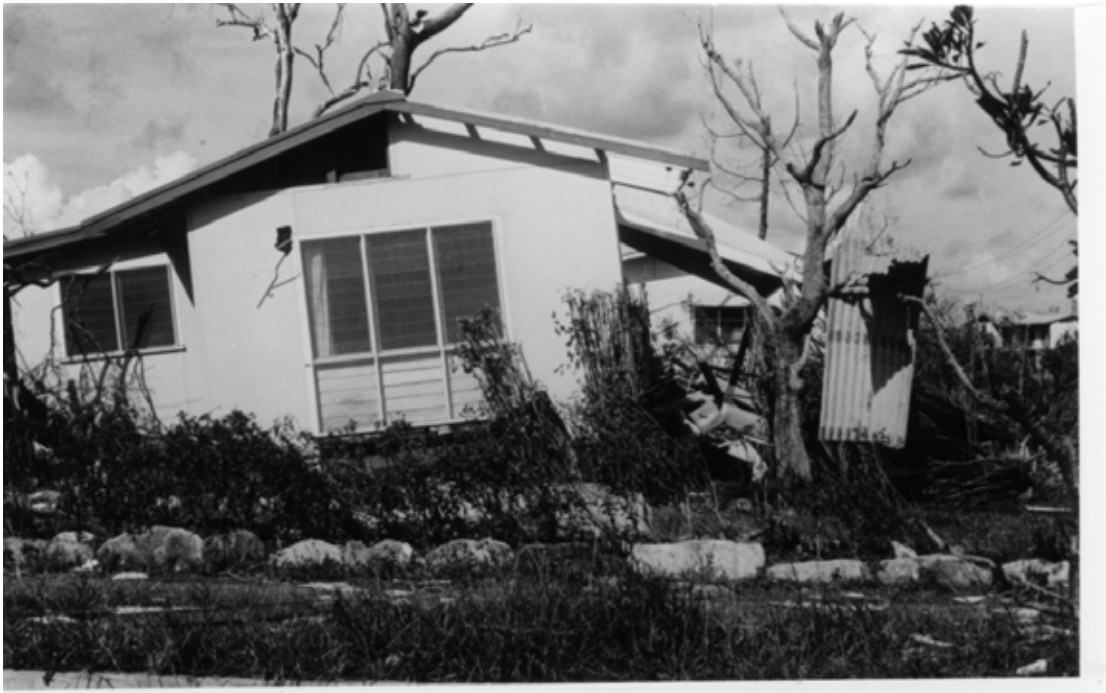
Fig. 5.9 - Pier collapse

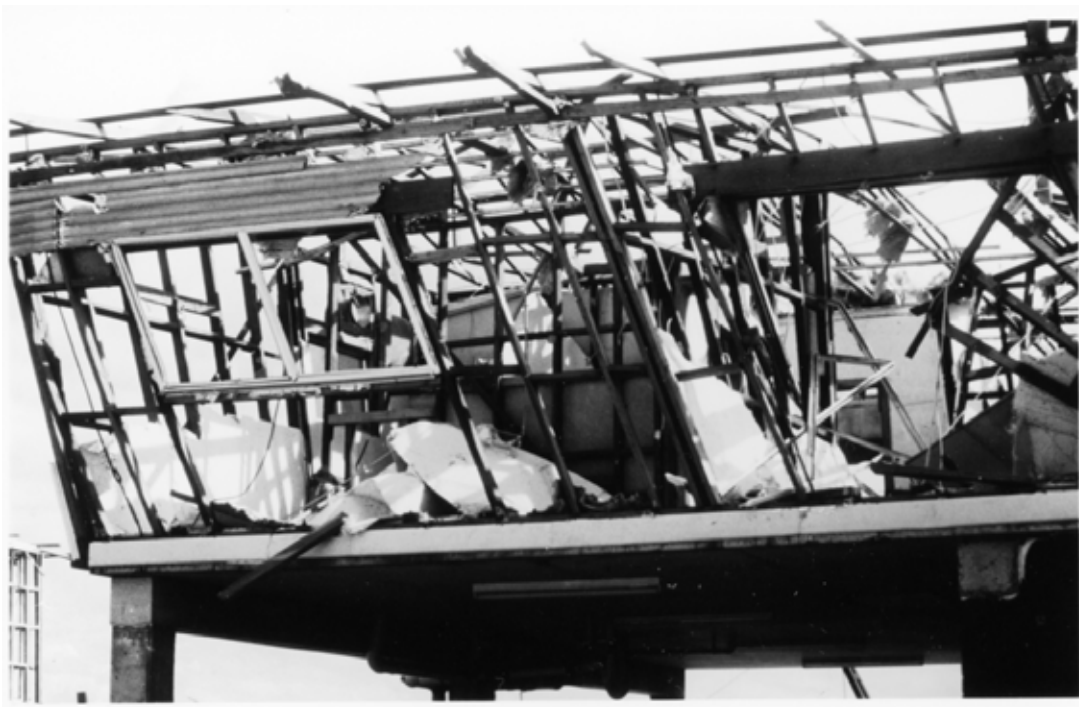
Fig. 5.10 - Failure by racking

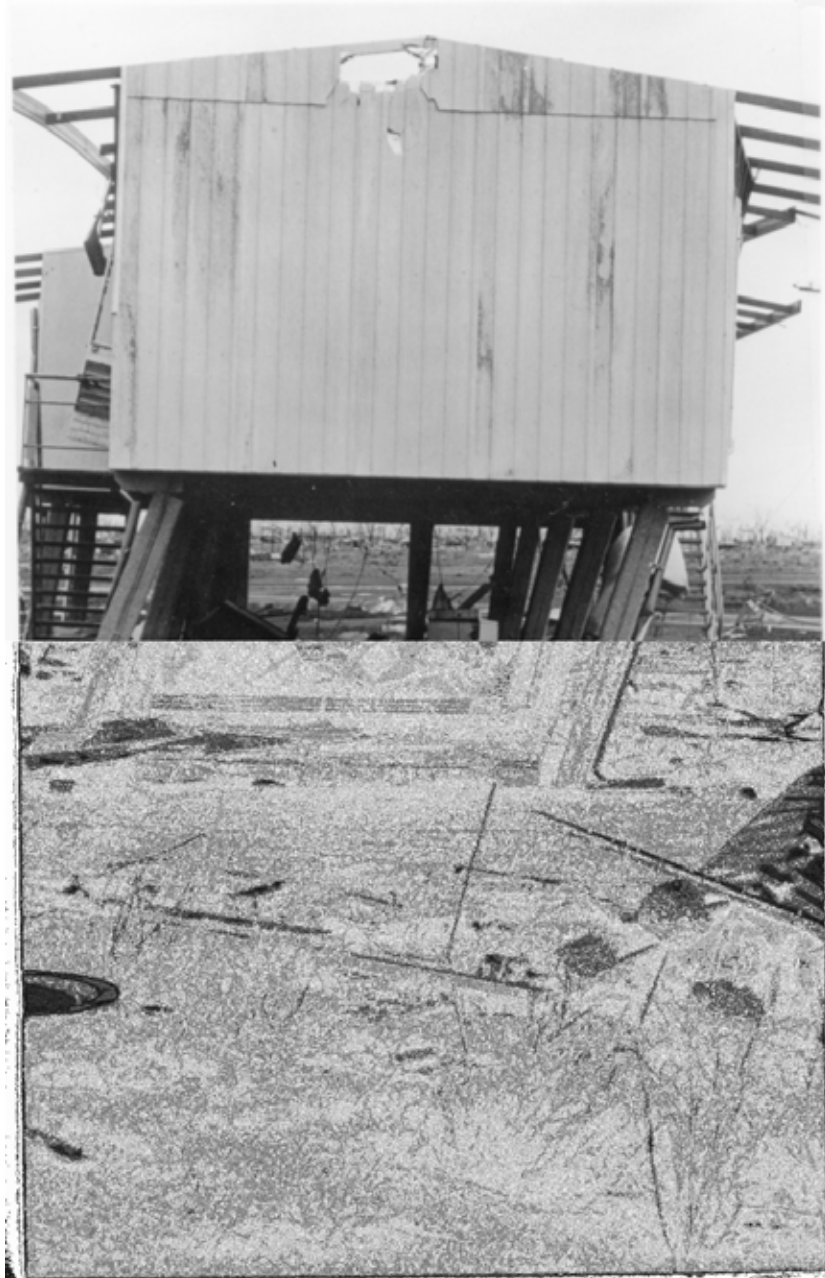
Fig. 5.11 - Failed pier

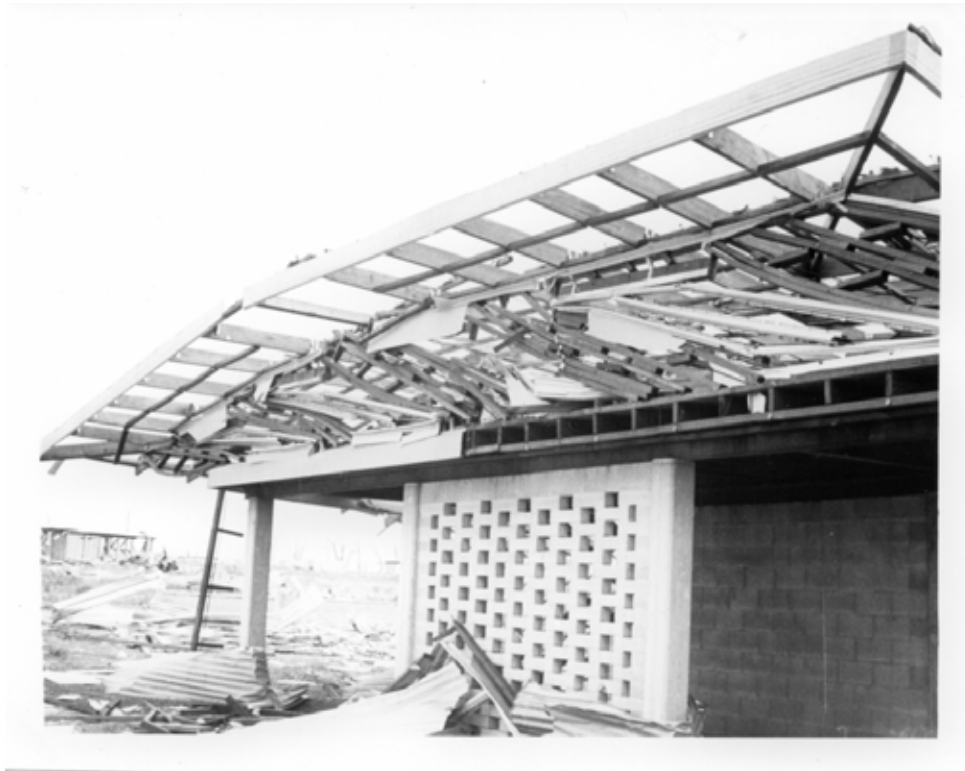
Fig. 512 - Collapse due to racking

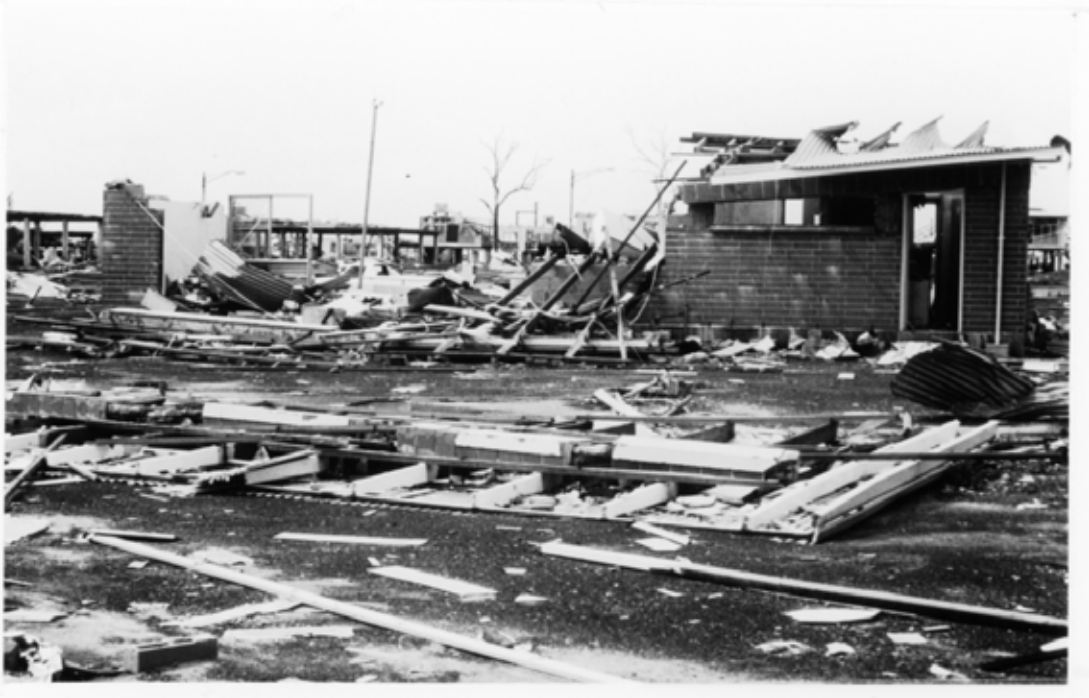
Fig. 5.14 - Failure of recent low set masonry home

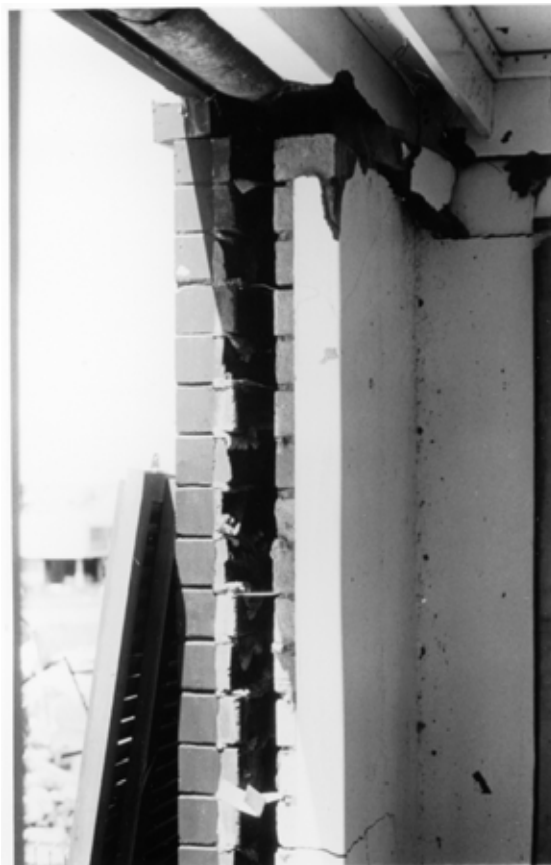
Fig. 5.15 - Lifting of bond beam

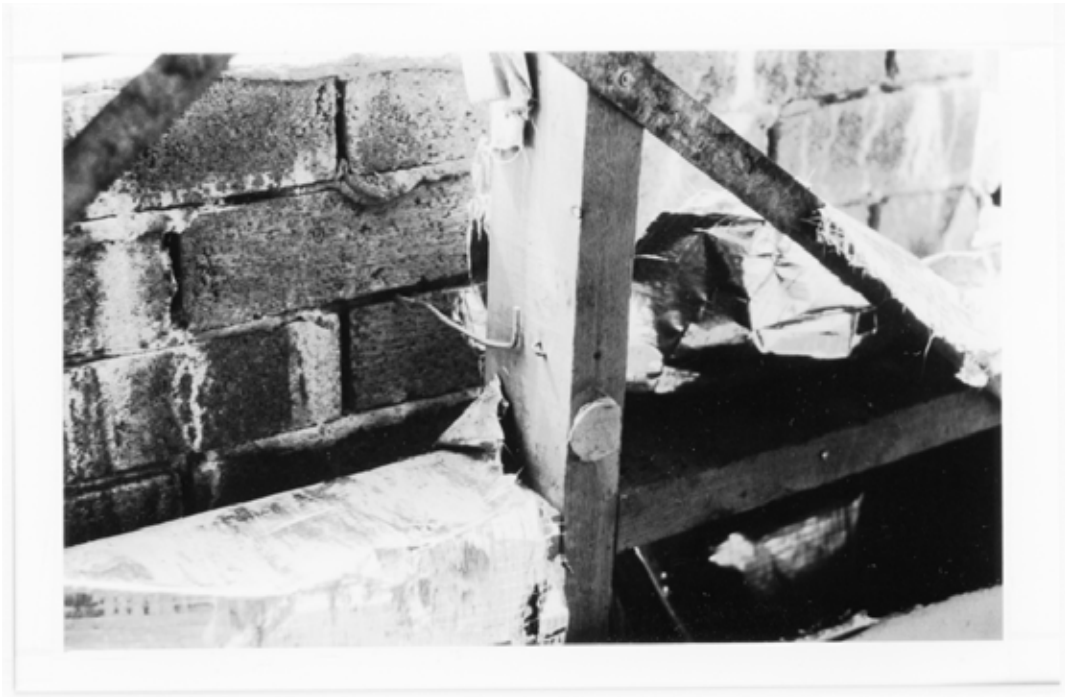
Failure of tie in brick veneer

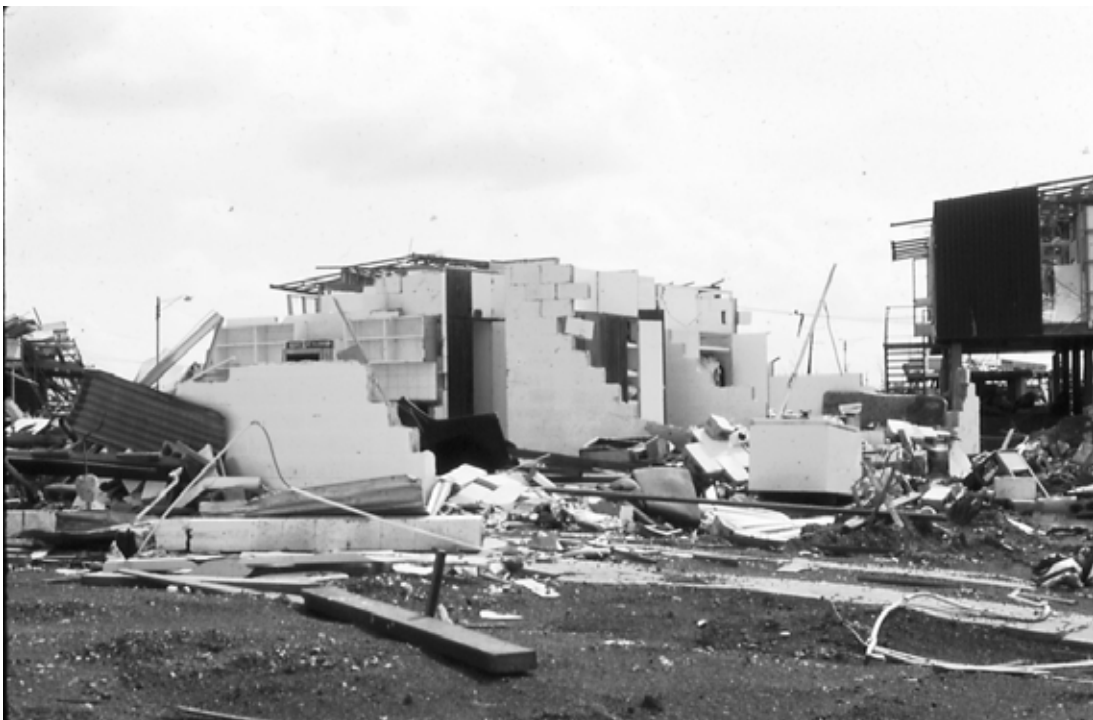
Fig 5.17 - Collapse of hollow block home

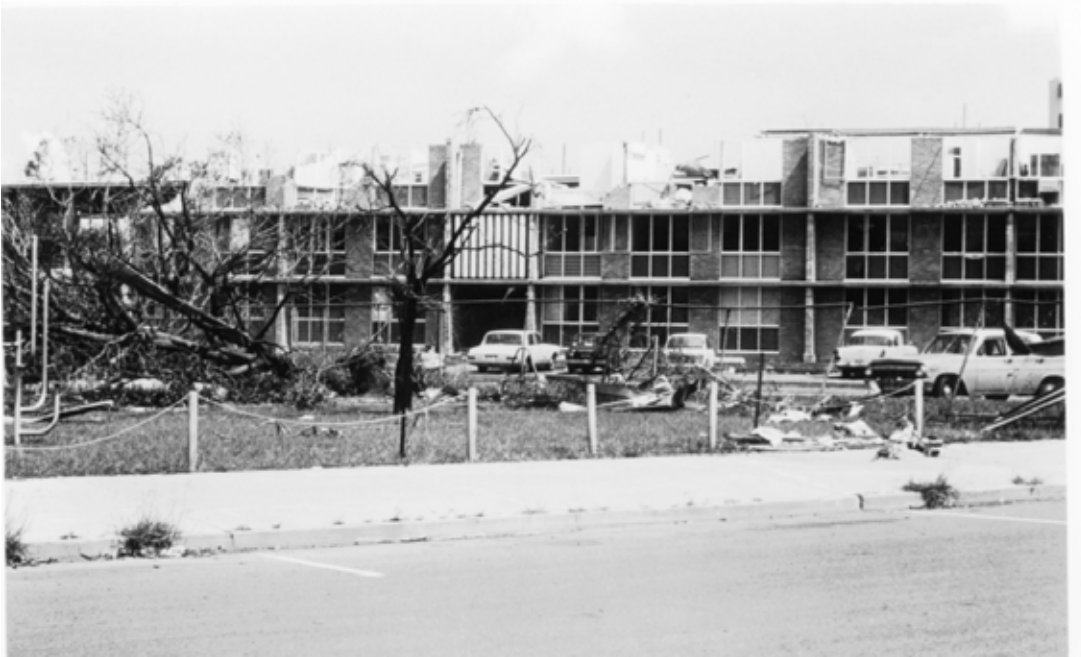
Fig 5.18 - Typical damage to flats

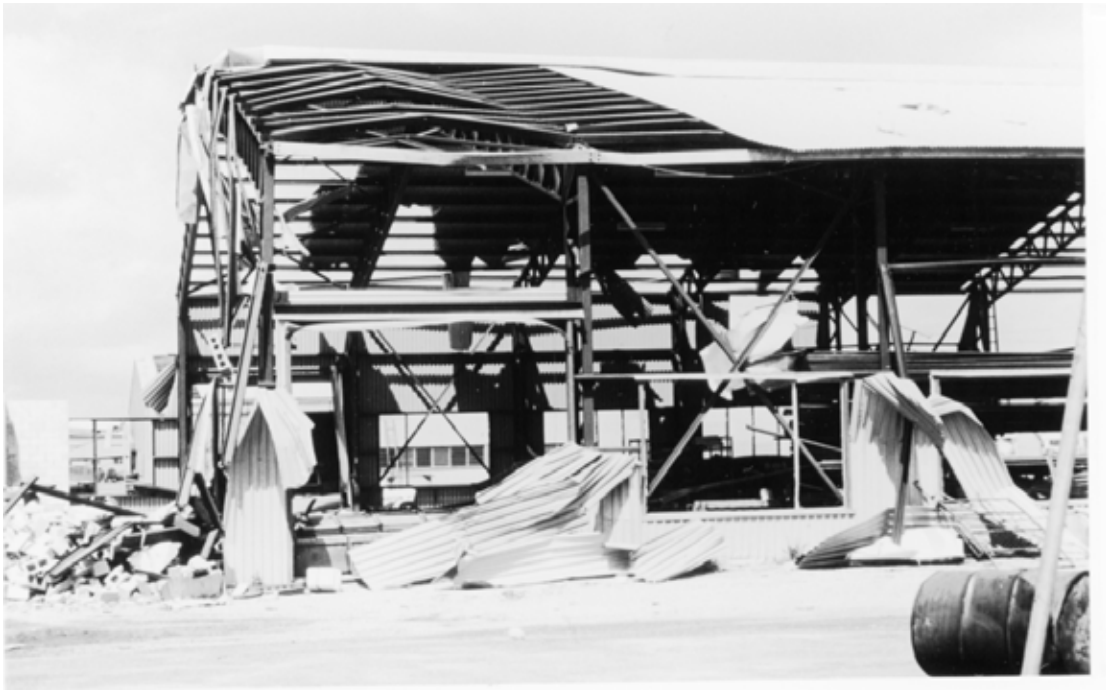
Fig. 5.20 - Buckled purlins on industrial building

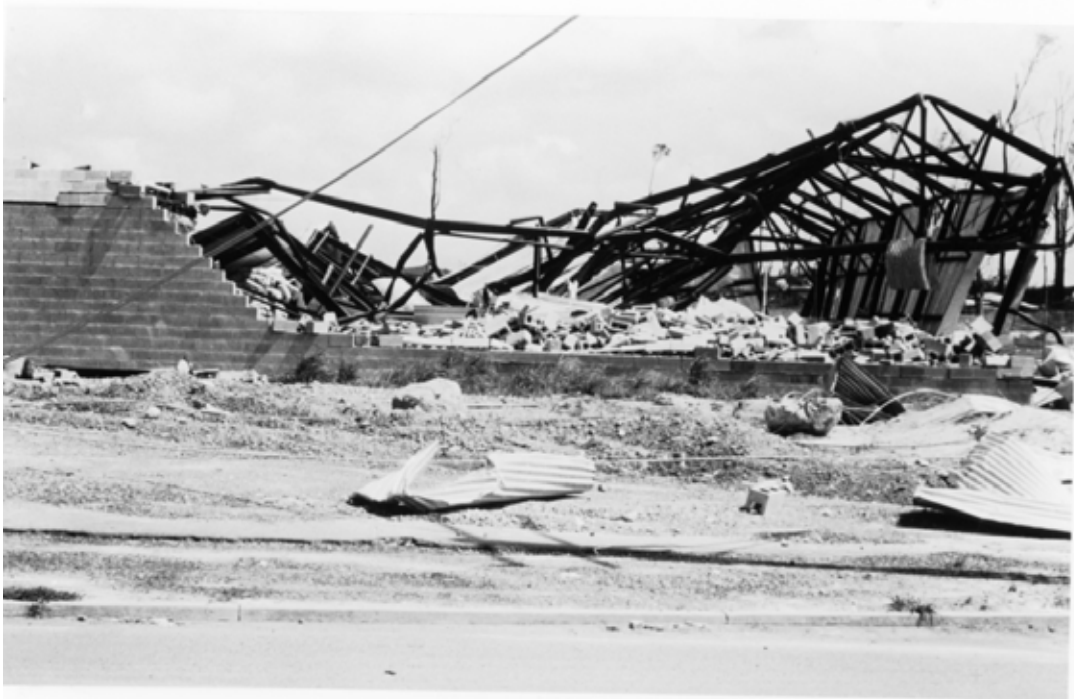
Fig. 5.21 - Collapsed steel building

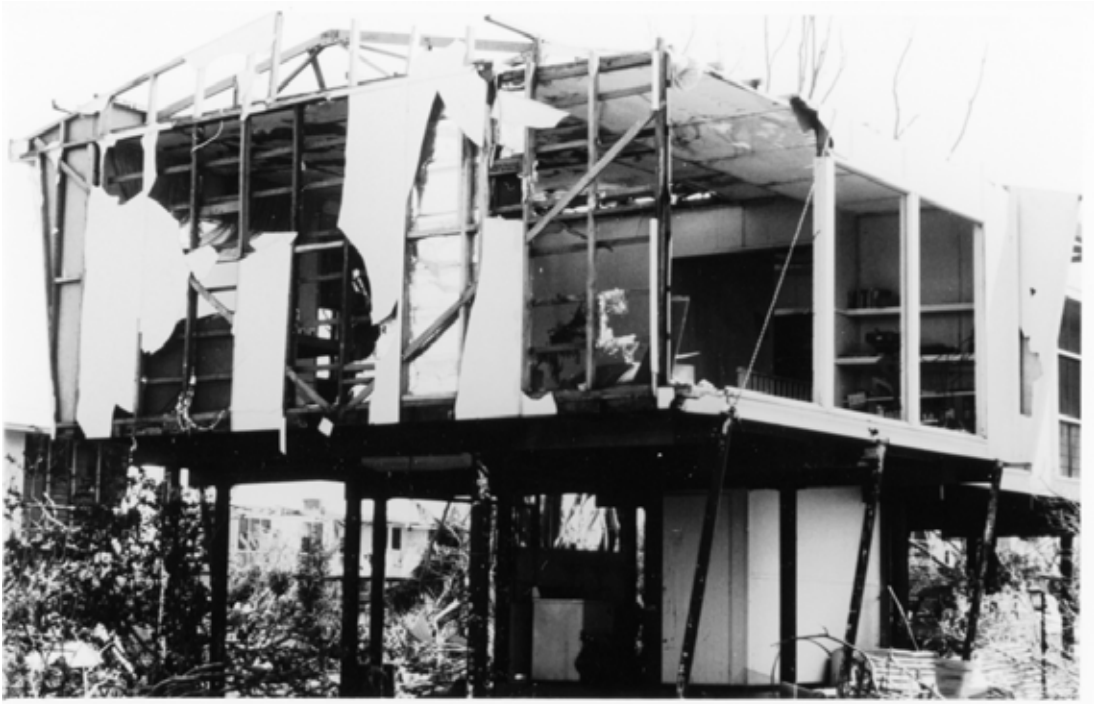
Fig. 5.22 - Battered wall cladding

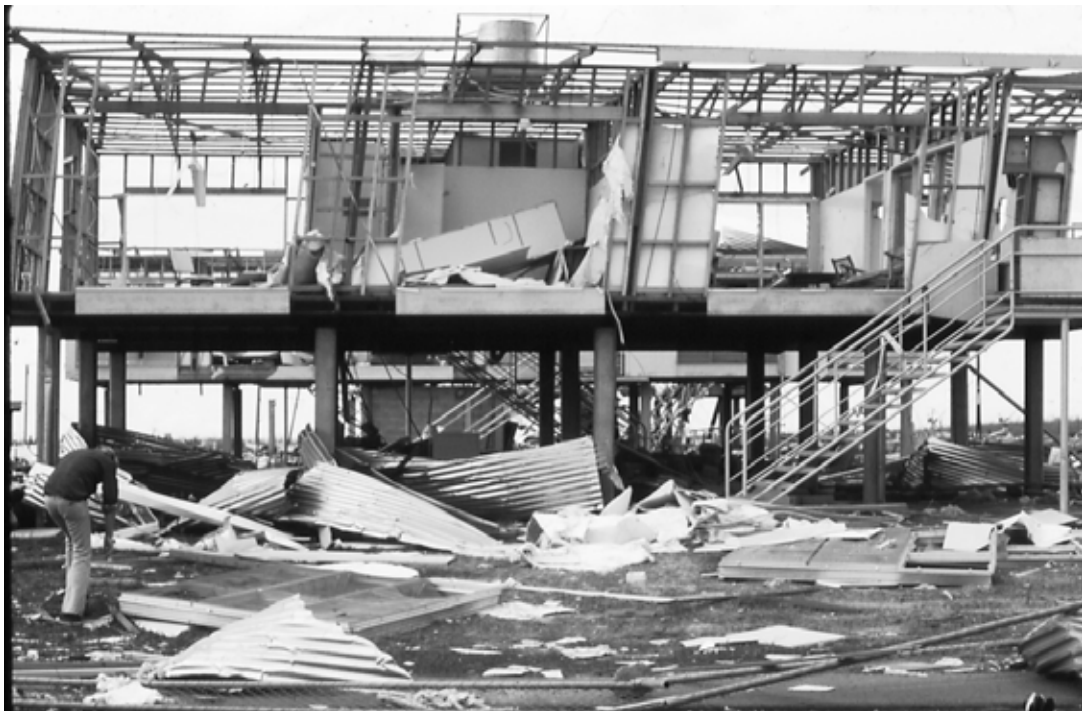
Fig. 5.23 - Having lost wall cladding

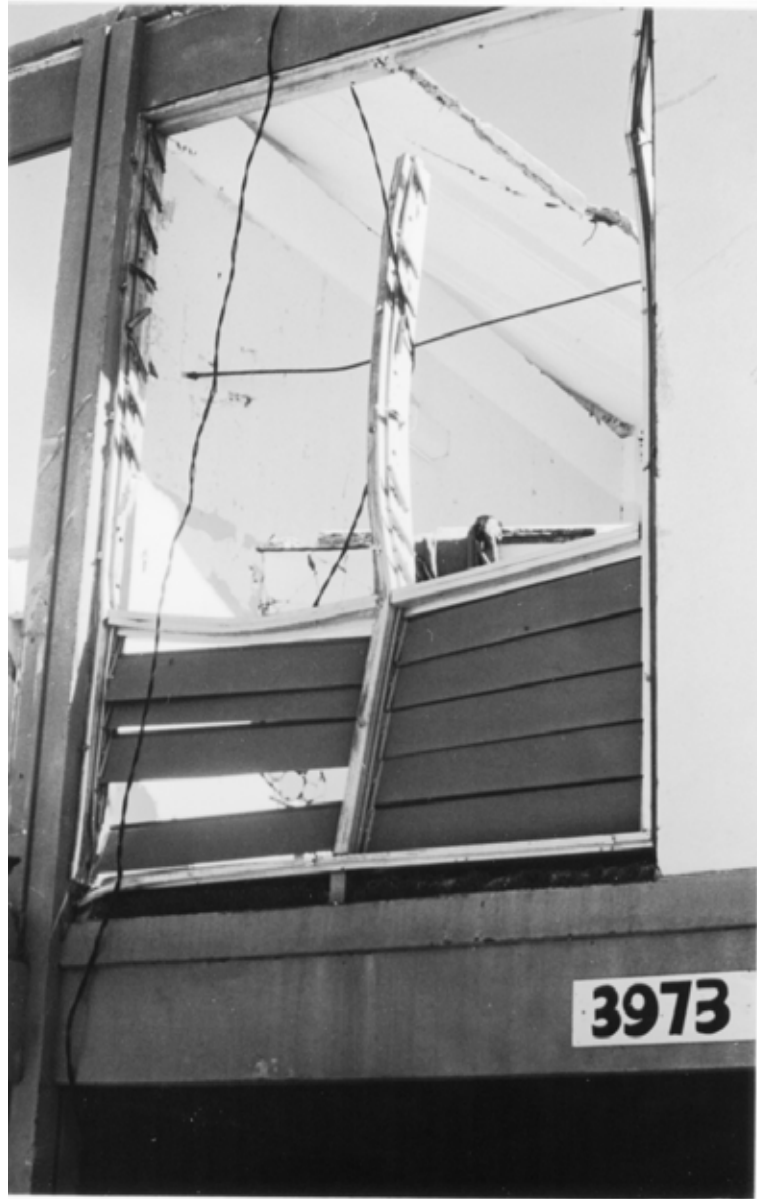
Fig. 5.26 - Battered window frame in concrete house

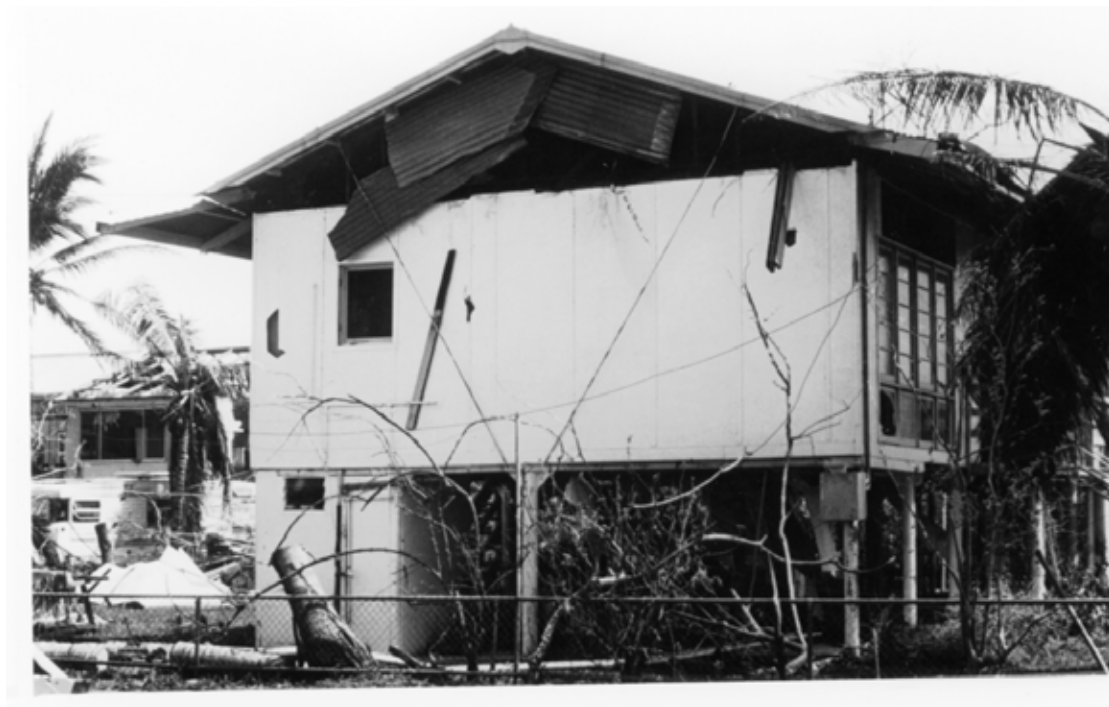
Fig. 6.4 - Damage to windward wall of house in Figure 6.3
