Failure Analysis of Base Plate Bolts of Radial Forging Machine

In this study, the failure analysis of base plate bolts of radial forging machine is investigated. Premature failure had occurred from the bolts shank-head fillet and threads zones. Hardness, impact and tensile tests are carried out to investigate the mechanical properties and spectrophotometer is used to evaluate the bolts chemical composition. Optical Microscope (OM) and Scanning Electron Microscope (SEM) are used for the investigation of microstructure, defects, fracture surface and failure causes. The fracture surface morphology shows that the crack growth consisted of bolts shank-head fillet and threads zones including the initiation zone, fatigue crack growth zone along with the beach marks and ratchet steps and the rapid final fracture zone. Stress analysis shows that the amount of pre-tightening selected lower than the proposed value leads to the joint loosening and shortens the bolt's fatigue life. In addition, based on the paper results, the existing flowchart for component fabrication is analyzed and a flowchart based on research field is presented to enhance the quality of radial forging machine parts.

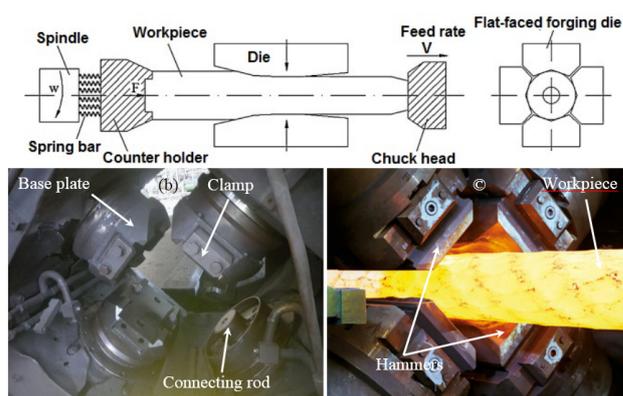
Fig. 1. Radial forging machine: a) Schematic operation, b) Drive system of hammers, c) Forged workpiece.

Radial forging machines usually have four hammers designed to forge the longitudinal workpiece. The drive system of hammers is either a mechanical or a hydraulic type. Radial forging machines with mechanical actuators are used for cold forging of small sections. Radial forging machines with hydraulic actuators are used for hot forging of large sections. The four pumps are driven by a motor that is coupled directly to the pressure cylinders and apply force to the hammers through the push rod. In a radial hydraulic forging machine, billets are squeezed by hammers in four directions and then workpiece is fed and rotated as in Fig. 1. The hammers are mounted on the base plate by two clamps and the base plate is mounted on the thrust ring by bolts. The thrust ring also serves as an intermediary between the connecting rod and the base plate [1-2].

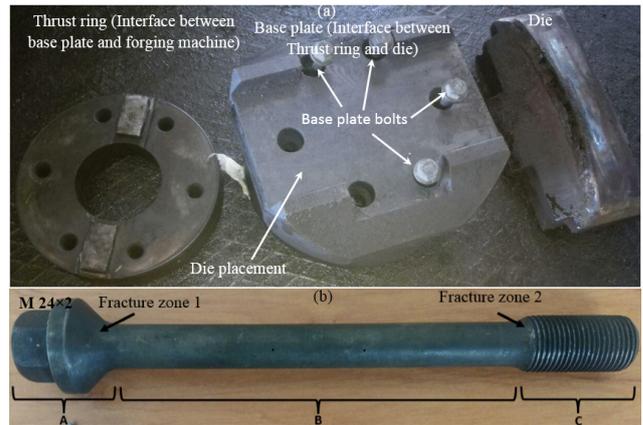
Table 1 lists the specifications of the radial forging machine. Fig. 2a shows the main components of the radial forging machine involved in the failure, and Fig. 2b shows a healthy bolt, most of which is broken severely from two zones of shank-head fillet and bolt threads.

Fig. 2. a) The main components of the radial forging machine involved in the failure, b) Bolt fracture zones.

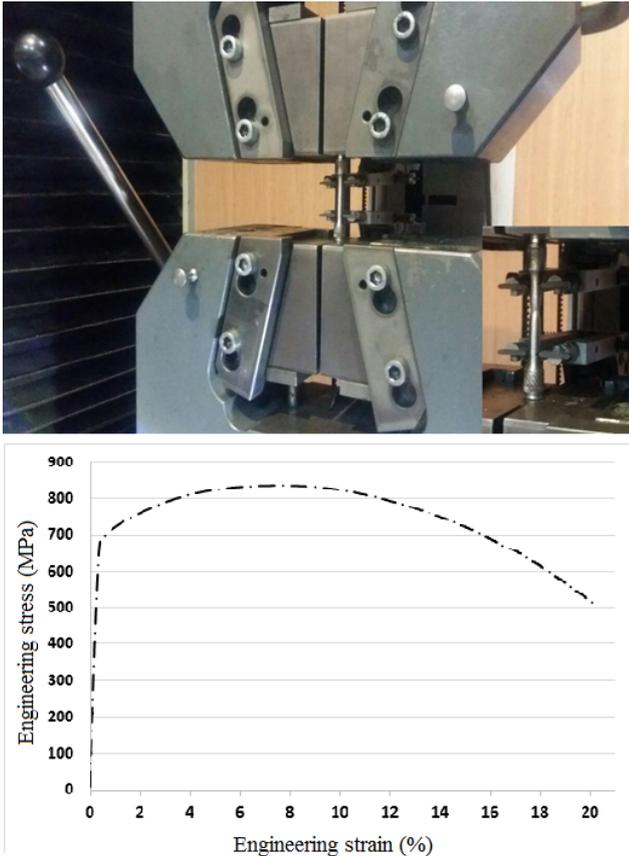
Using the results of the tensile tests, the final strength and length change are measured. The mechanical properties of DIN1.6580 test material for the base plate bolt are listed in Table 3 and the stress-strain curve of the material engineering is drawn in Fig. 3. The first row of Table 3 shows average values of the three tested samples, the second row is standard alloy sample values extracted from the steel handbook and the third row shows values proposed for the manufacture of plate bolts by GFM. Tensile tests performed on the prepared samples indicate that the values obtained are within the acceptable range of the standard alloy and the proposed alloy by GFM.

Fig. 3. a) Test machine with tensile specimen and extensometer, b) Engineering stress–strain curves of DIN1.7034 steel.

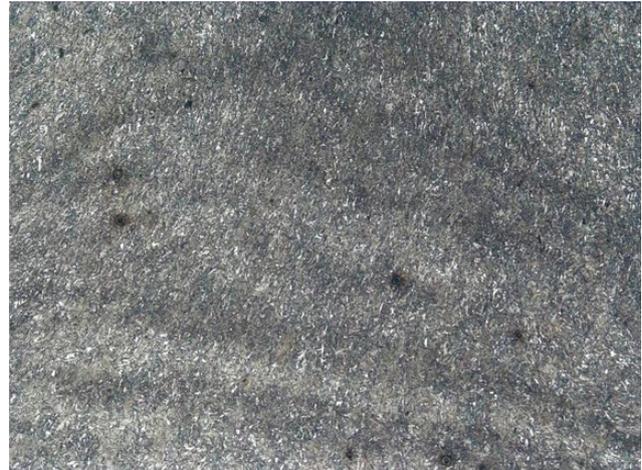
The micrographs of the base plate bolts examined are shown using optical microscopes in Fig. 4. It is seen that the structure of the base plate bolts is of the martensite steel type.

Fig. 4. Microstructure of the cross-sectional area of the base plate bolt after etching with 100× magnification.

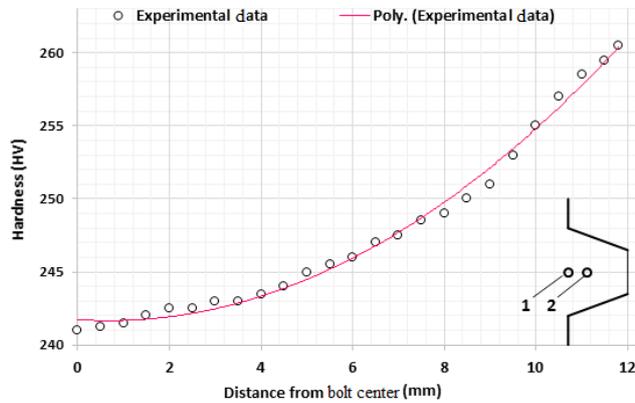
First, the hardness test is performed on the cross-sectional area of the specimen by applying 30Kgf force for 10 seconds and the hardness is plotted from center of bolt to bolt outer diameter in Fig. 5. Then the hardness test is performed on wire cut specimen in three different threads. The thread Vickers hardness is measured in points 1 to 3 of Fig. 5 in accordance with the requirements of Table 18 of ISO 898-1: 2009 (E) [15]. The test force is selected according to the standard 2.942N (Vickers hardness test HV 0.3). The Vickers hardness value for bolts without carbonization at point 2 according to the standard should be greater than the Vickers hardness at point 1 according to Eq. (1) [15].

In Fig. 5, the height of the not carburize zone E, must be in accordance with ISO 898-1: 2009 (E). The measured hardness values of the threads are in accordance with the standard and are valid in Eq. (1). The results of Fig. 5 show that the bolt hardness increases from center to external diameter. The hardness values shown in Fig. 5 and the hardness values of points 1 and 2 of Fig. 5 are within the bolts standard material and, therefore, the heat treatment performed on the bolts is correct, so hardness does not impose any problems in the bolts.

Fig. 5. Hardness distribution from center to outer diameter of the bolt.

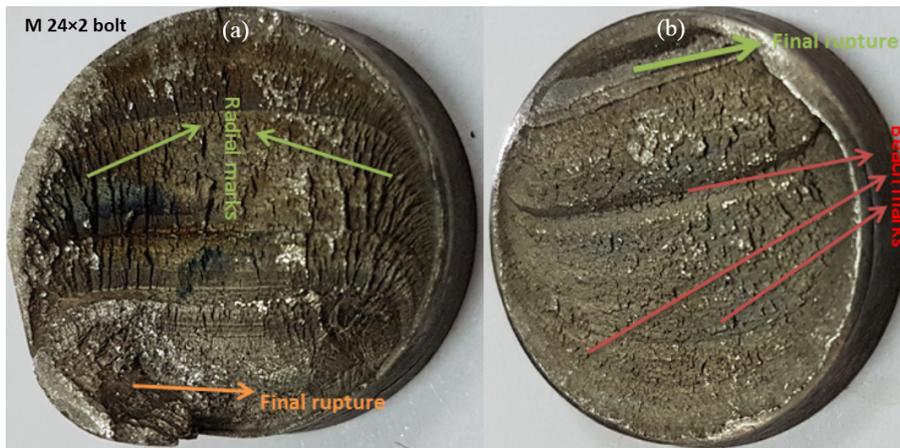
Fig. 6 and Fig. 7 show the optical examination of the fracture surface of the bolts, where fatigue has been identified as the main cause of failure with the zones of initial crack initiation A, crack propagation B, and final fast fracture C. Fracture surfaces have radial line and beachmarks that are marks of fatigue failure. The surface is surrounded by ratchet steps, which can be the origin of the initiation of radial lines. The beachmarks and the radial lines are signs of fatigue failure. Further examination of the fractured surfaces of the bolts suggests that the fatigue zone shown in Fig. 6 and Fig. 7 is relatively large and approximately 80% of the total fractured surface.

Fig. 6. Macro morphology of fracture surface of the radial forging machine bolts shank-head fillet (zone 1).

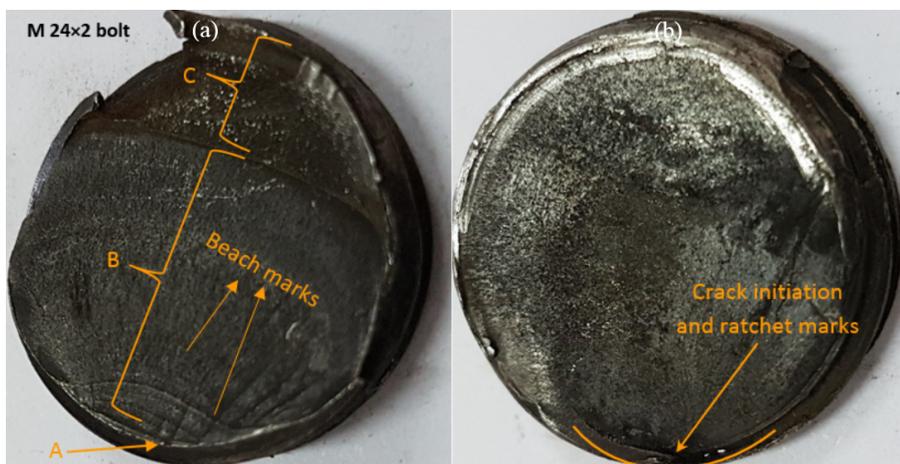
Fig. 7. Macro morphology of fracture surface of the radial forging machine bolts threads (zone 2).

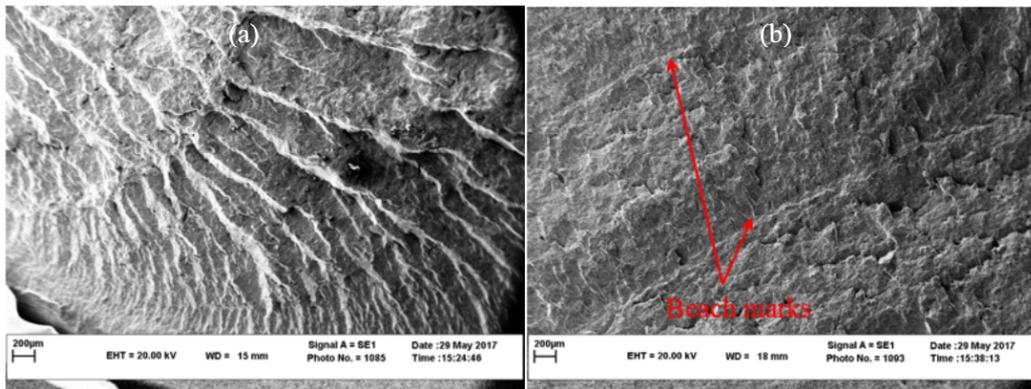
Fig. 8 and Fig. 9, respectively, show the SEM fracture surface of the initial crack zone of the bolts of Fig. 6 and Fig. 7, respectively. The SEM results also show the effects of fatigue including beachmarks and striations with high magnification. Similar results to the SEM on failure analysis (e.g. [18-19]) of fatigue effects including beachmarks and striations have been reported in fatigue loaded specimens.

Fig. 8. a) Striations indicating fatigue failure, b) Beach marks indicating fatigue failure.

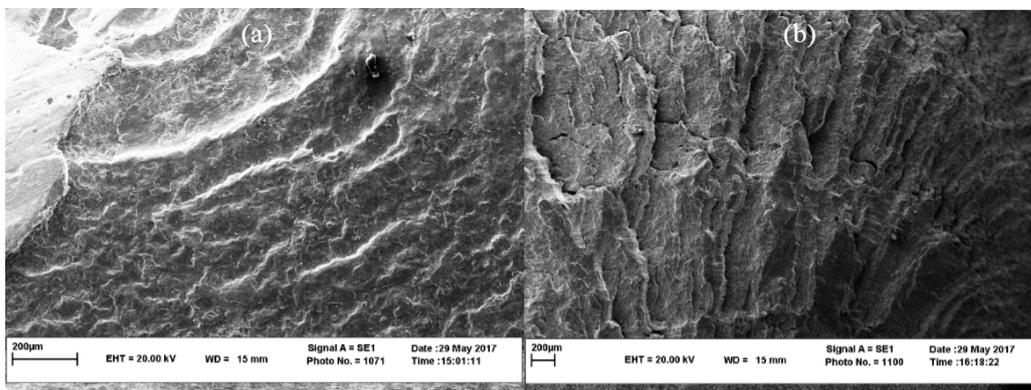
Fig. 9. a) Striations indicating fatigue failure, b) Beach marks indicating fatigue failure.

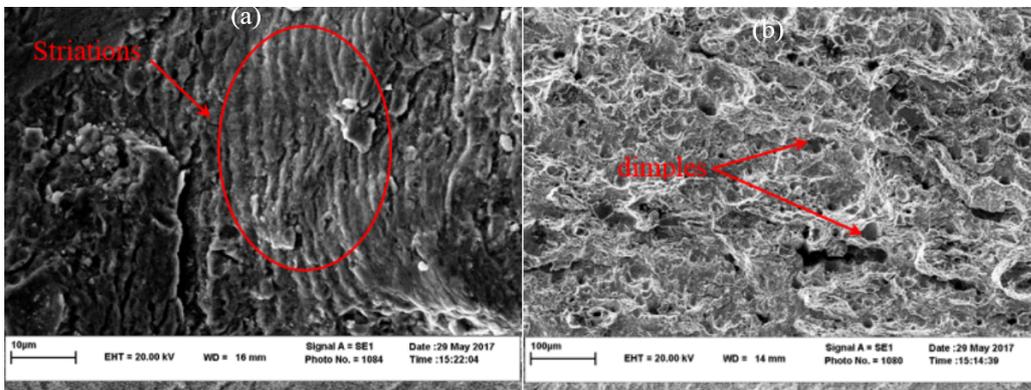
Fig. 10. a) Striations indicating fatigue failure, b) Shear failure.

Fig. 10 shows the SEM fracture surface of the fatigue crack growth zone B and the final fast fracture zone C of the broken bolt Fig. 7a. The averaged distance between the relatively large striations in Fig. 10a is obviously indicative of a low cycle fatigue failure in this study. Fig. 10 shows the SEM fracture surface characterization of the dimple shear fracture features, which is the last cracking step, and the large number of dimples in the fracture propagation zone shows excellent bolt toughness. The results of the impact tests confirm the toughness of the bolt fracture surface. Similar research has been reported on failure analysis (e.g. [20-21]) of fatigue effects including beachmarks and striations in the bolts.

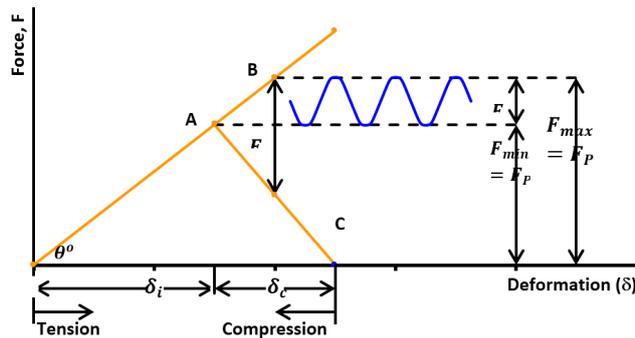
Fig. 11. Diagram representing the beneficial effect of a pre-tightening on bolts.

The cyclic stress amplitude imposed on a bolt is highly dependent on pre-tightening, because if the pre-tightening increases, there is a decreasing cyclic alternating stress σ_a . Lack of adequate pre-tightening promotes premature fatigue, leading to fatigue crack growth under service loading conditions. Table 5 lists calculations of the proposed bolted joint and current work with details. Bowman [26] recommends a pre-tightening of 75 percent of proof load, which is about the same as the RB&W recommendations for the reused bolts.

Hence, one of the root cause of failure can be a deficient pre-tightening of the base plate bolts, which could originate a significant alternating stress amplitude. Bolts were going suffering some failure at bolts shank-head fillet and threads zones. It is well-known that cracks generally start at the threads fillet and improper shank-head fillet where the stress concentration is higher. One reliable indication is also revealed by the presence of beachmarks [28-29], as is shown in this failure analysis. For all fractured base plate bolts, the root cause is the same with fatigue marks.

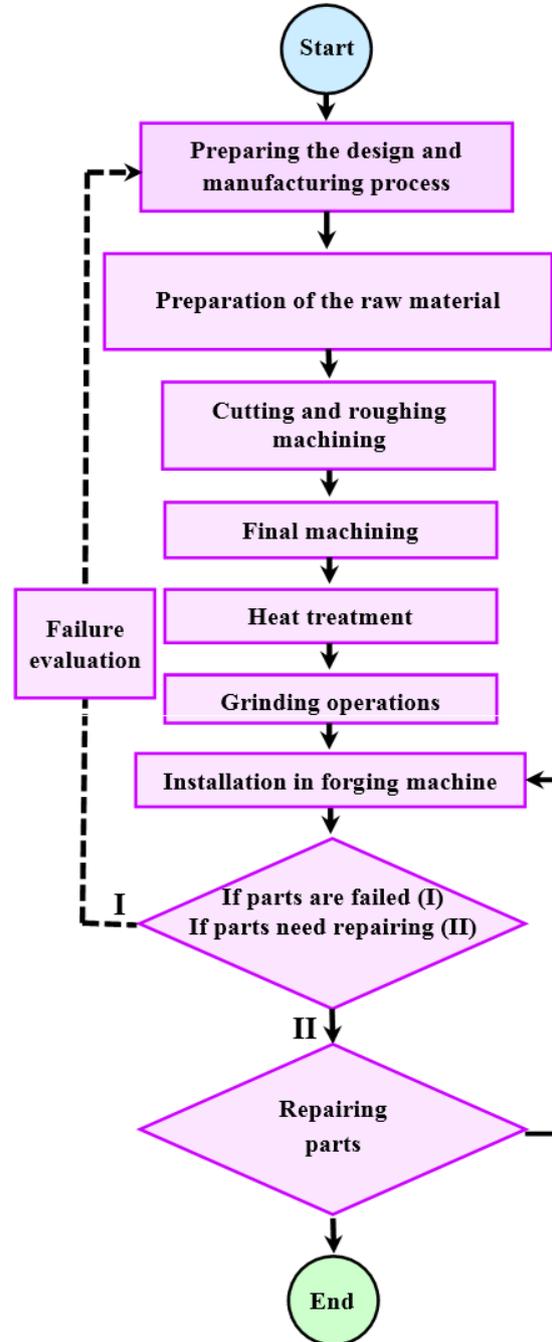
Parts wear is one of the most important problems in the mining and industrial sector where wear in critical situations can cause failure. One solution is to manufacture new parts and replace them with worn parts, but this choice is largely costly. Another method is repair welding of the parts by welding and then machining [30]. The solid arrow in flowchart (Fig. 12) shows how to fabricate the forging machine parts in the steel complex. To improve the quality of the radial forging machine parts, the dashed line section of the algorithm is developed to show feedback on the broken parts. The present algorithm includes drawing parts and manufacturing process (from raw material step to final machining step), material selection, initial cutting to roughness dimensions, rough machining to parts geometry with different machine tools (lathe, milling, grinding, etc.), removing sharp edges to eliminate thermal stress concentration, heat treatment of the parts to the desired hardness, final machining and grinding, and closing parts on machine. After the radial forging machine has been operated and the sound has been created by the machine, there are two modes: the clearance caused by wear that needs repair and the part is reused or the part failure that is discarded. For improvement of the bolts quality, the fatigue life and the investigation of failure cause are added to the new algorithm. Due to the sleep of the radial forging machine and the high cost of fabrication of the parts, this method is suggested as the least costly method for improving the parts.

Fig. 12. Flowchart of the manufacturing process and parts failure detection.
