Research Task: ANZAC Bridge

Assessment Task 1 – Civil Structures

Contributor(s): Rohith Gajangi – 2016 HSC Engineering Studies

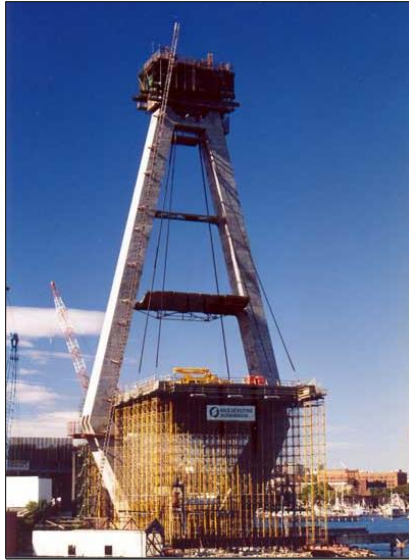
Eastern Tower, 1994

The ANZAC bridge's structure consisted of two towers, one on the western end and the other on the eastern. The western tower, along with the first three deck segments, were built at the same time and completed by **November 1993** ^[5], whilst the Eastern tower wasn't completed till **September of 1994**, followed by the Eastern Deck in **June 1995**. The bridge deck was constructed in 10 metre concrete segments and the first three segments were initially supported by scaffolding. However, when tower construction was completed, the first stay cables were installed. They replaced the scaffolding and connected to the deck segment at its furthest edge from the tower.

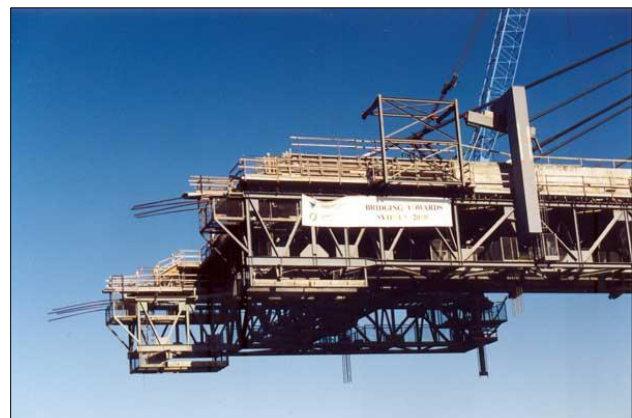
Formtraveller on the western deck

The construction process of the ANZAC bridge over the water utilised a recent innovation - The Formtraveller - which is, in effect, a travelling formwork. The Formtraveller was supported by the leading edge cables of the previous segment, whilst it provided support for the next 10m concrete segment to be cast. The Formtraveller was itself a substantial construction as it was about 30m long and 32m wide, and weighed almost 280 tonnes. ^[4]

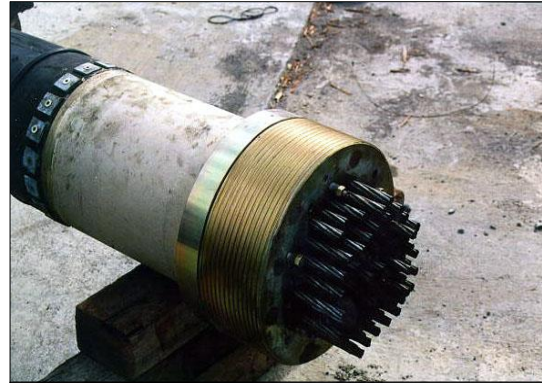
Wire strands within stay cables

Throughout the entire bridges structure the number of strands in each stay cable varied, increasing in number from 25 to 74 towards the centre of the bridge. [5]

12m lengths of polyethylene sheath were welded together on the deck and wire stands were drawn in.

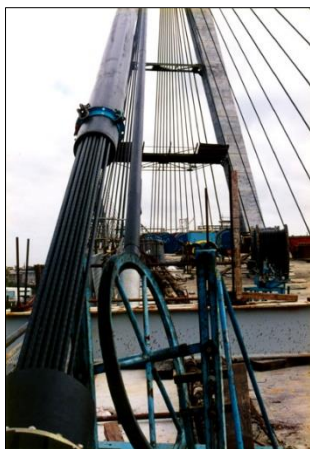
The strands were then individually drawn into place through the polyethylene sheath from the deck level using a drawing wheel. They were secured in an adjustable anchorage point in the tower head, the strand was cut to length and fixed at deck level.

Cable strands within the polyethylene sheath and the drawing wheel.

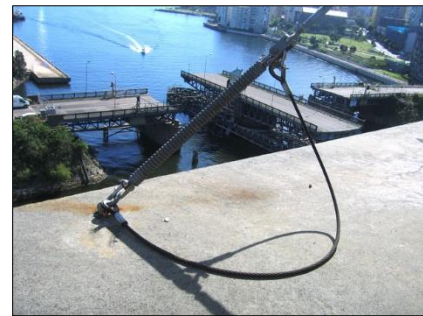
Antivibration cable

Initially the stay cables were subject to serious vibrations. Experimentation using heavy ropes tying the stay cables diagonally back to the deck solved the problem. The permanent solution replaced the ropes with thin spring loaded stabilising cables between the stay cables and the deck. The spring failure safety link was later added.

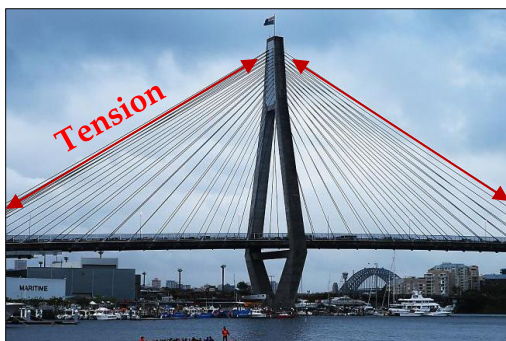
The Stay Cables within the ANZAC Bridge's structure are in TENSION just like all cable stayed bridges.

Stress in Stay Cables of the ANZAC Bridge.

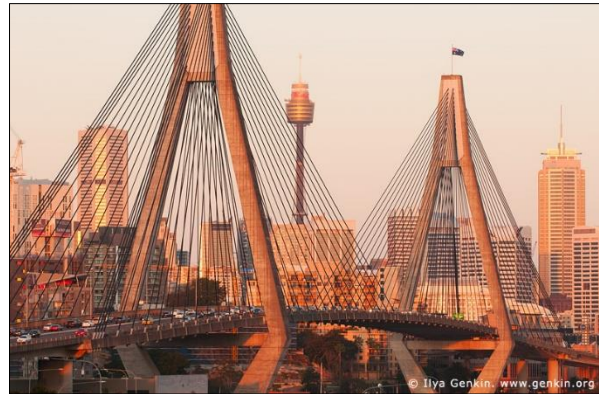
Two delta shaped towers of the ANZAC Bridge.

The main features of the substructure are the two delta-shaped reinforced concrete towers approximately 120 metres high with a maximum width of 44.23 metres.

Construction of the tower legs commenced when the base segment of each tower was complete. The base segments consist of a solid block of concrete, 5.5 metres high and 6.5 metres wide, poured in two halves. The second segment was constructed with formwork tied back to a triangular frame anchored to the top of the base segment of each tower.

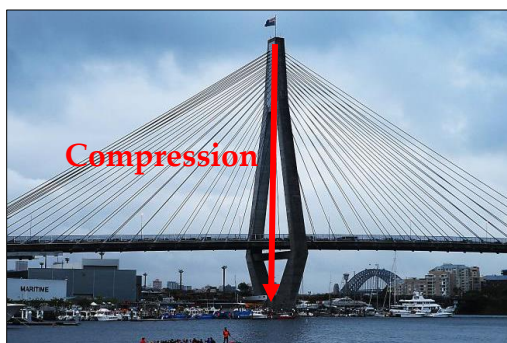
The towers within the ANZAC Bridge's structure are in **COMPRESSION** just like all cable stayed bridges.

Stress in towers of the ANZAC Bridge.

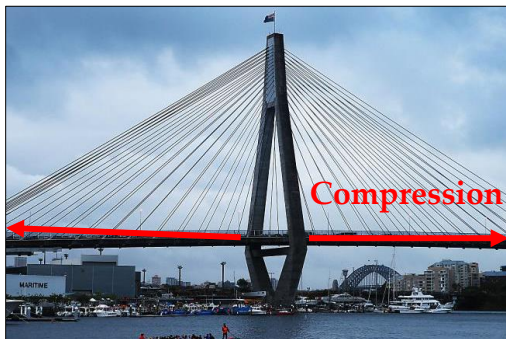
The deck within the ANZAC Bridge's structure are in **COMPRESSION** just like all cable stayed bridges.

Stress in towers of the ANZAC Bridge.

The deck was a 32.2 metre wide superstructure of cable-stayed spans which is a prestressed concrete open grillage deck system, consisting upon two longitudinal edge beams, cross girders at 5.17 metre spacings and a deck slab of 0.25 metre thickness.

Each deck segment weighs approximately 460 tonnes. During construction, as each deck segment is cast on one side of the tower it must be balanced by one on the other side. The deck segments towards land were cast first. The deck was erected by using cantilever methods, using a form traveller on one side of the pier (ie. water side) and a rolling form on the other (ie. land side).

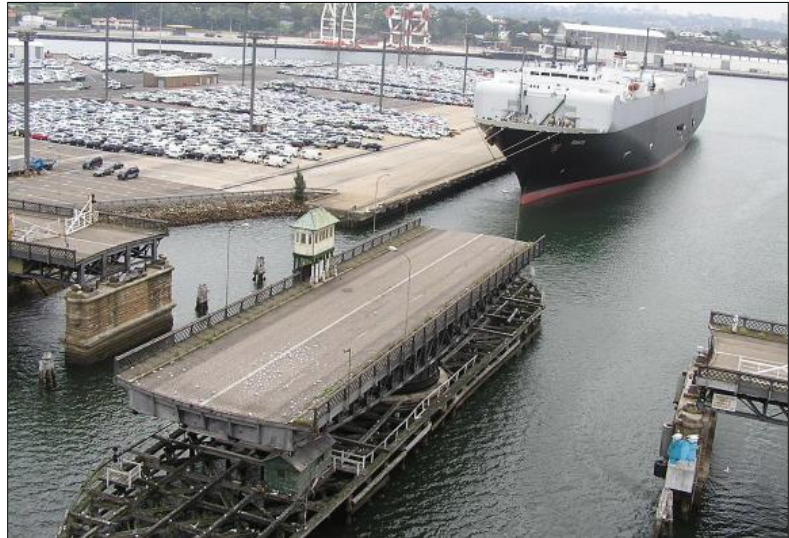
Opening of bridge due to large ships coming into Johnston's bay.

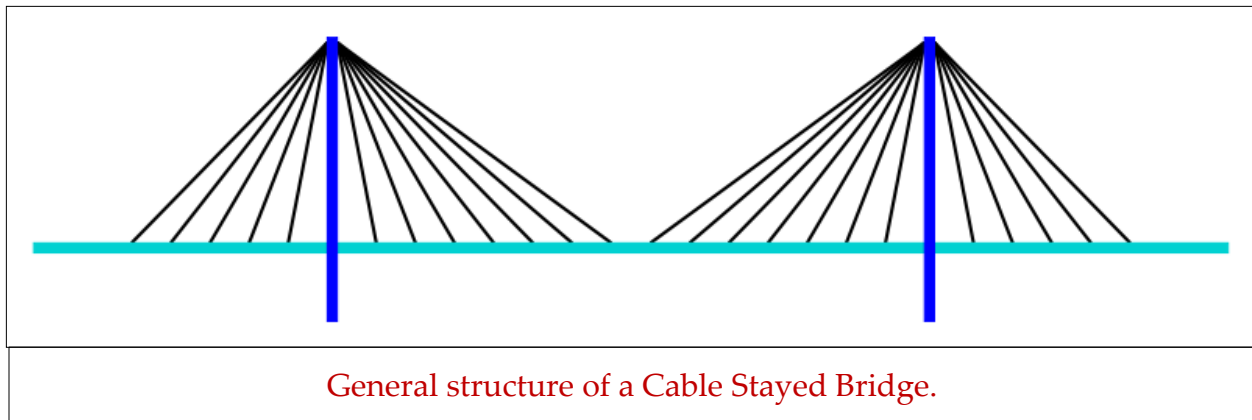
A cable stayed bridge has one or more towers (or pylons), from which cables support the bridge deck. A distinctive feature are the cables which run directly from the tower to the deck, normally forming a fan-like pattern or a series of parallel lines. This is in contrast to the modern suspension bridge, where the cables supporting the deck are suspended vertically from the main cable, anchored at both ends of the bridge and running between the towers. ^[10]
