***REPORT ON CYCLONE***

***“TRACY”***

**- Effect On Buildings -**

**DECEMBER 1974**

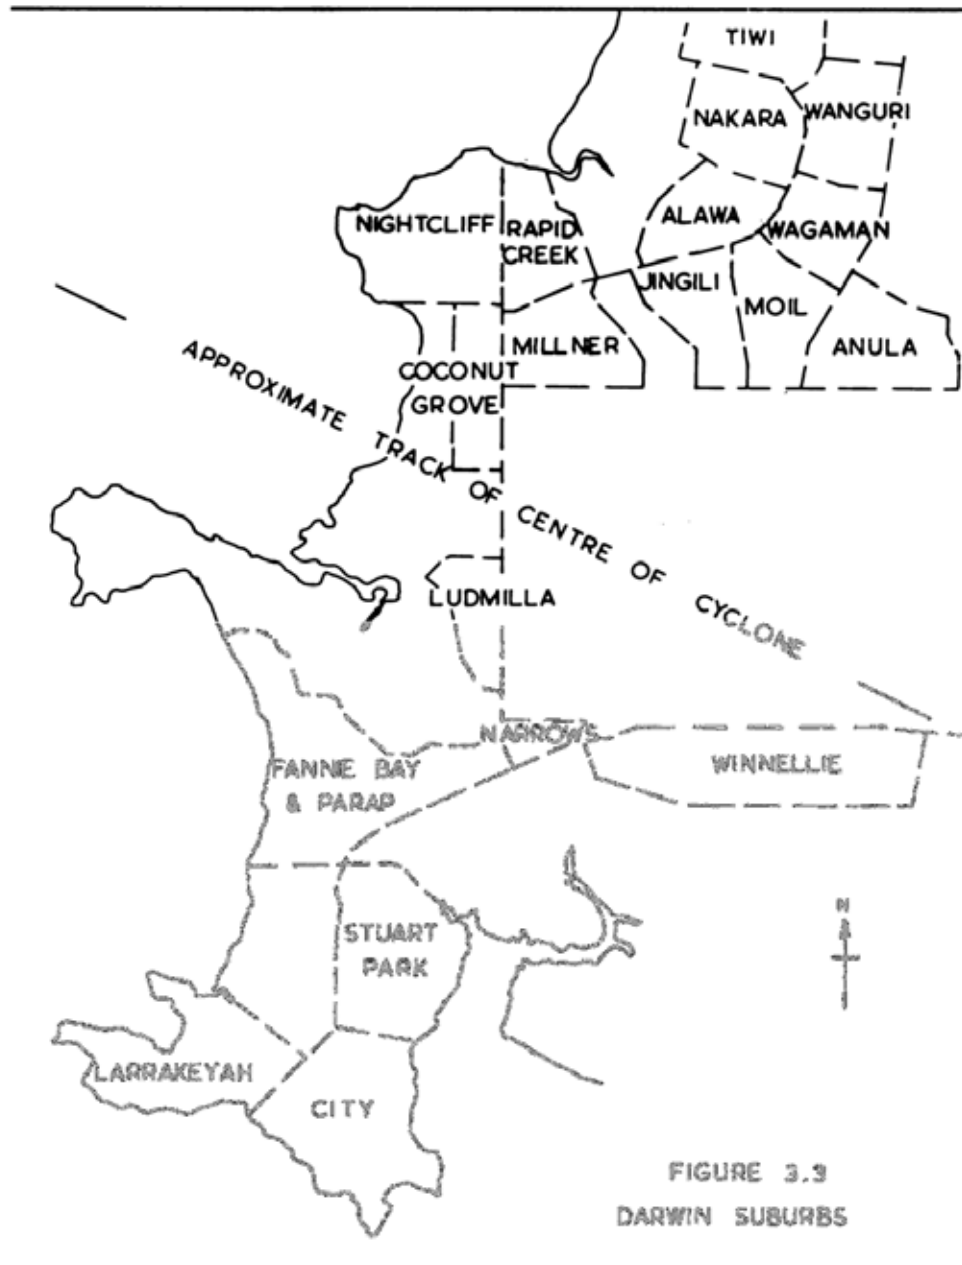
FIGURE 3.3  
DARWIN SUBURBS

Figure 3.1 is a map of the approximate path of cyclone “Tracy” from its formation until it had passed Darwin. Figure 3.2 shows the approach to Darwin in more detail including an indication of the size of the cyclone. Figure 3.3 is a map of Darwin itself showing the layout of the suburbs and the approximate path of the centre of the eye.

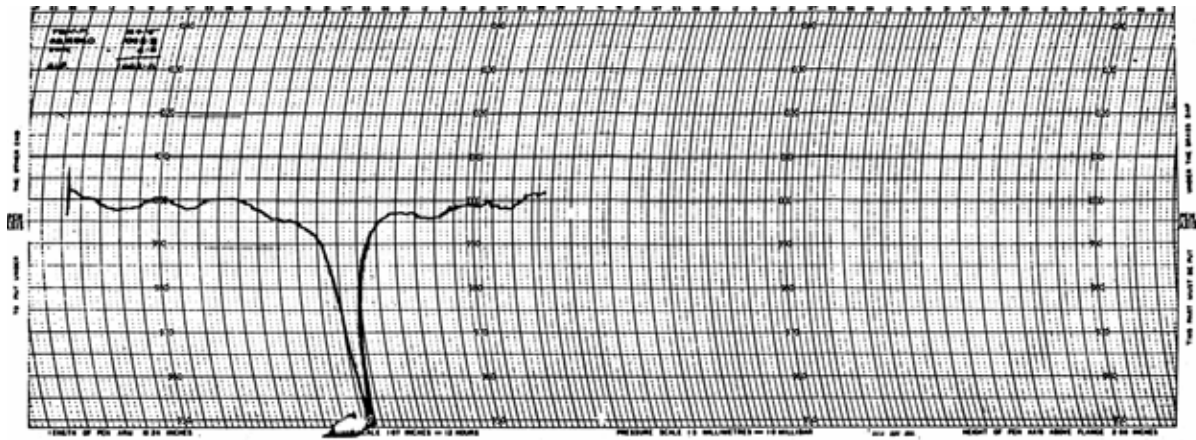
FIGURE 3.4 BAROGRAPH RECORD FROM DARWIN OFFICE OF BUREAU OF METEOROLOGY  
(By courtesy of the Bureau of Meteorology)

Figure 3.4 is a copy of the barometric pressure record obtained at the Bureau of Meteorology's office in Darwin, which was located in the city area just to the South of the passage of the eye.

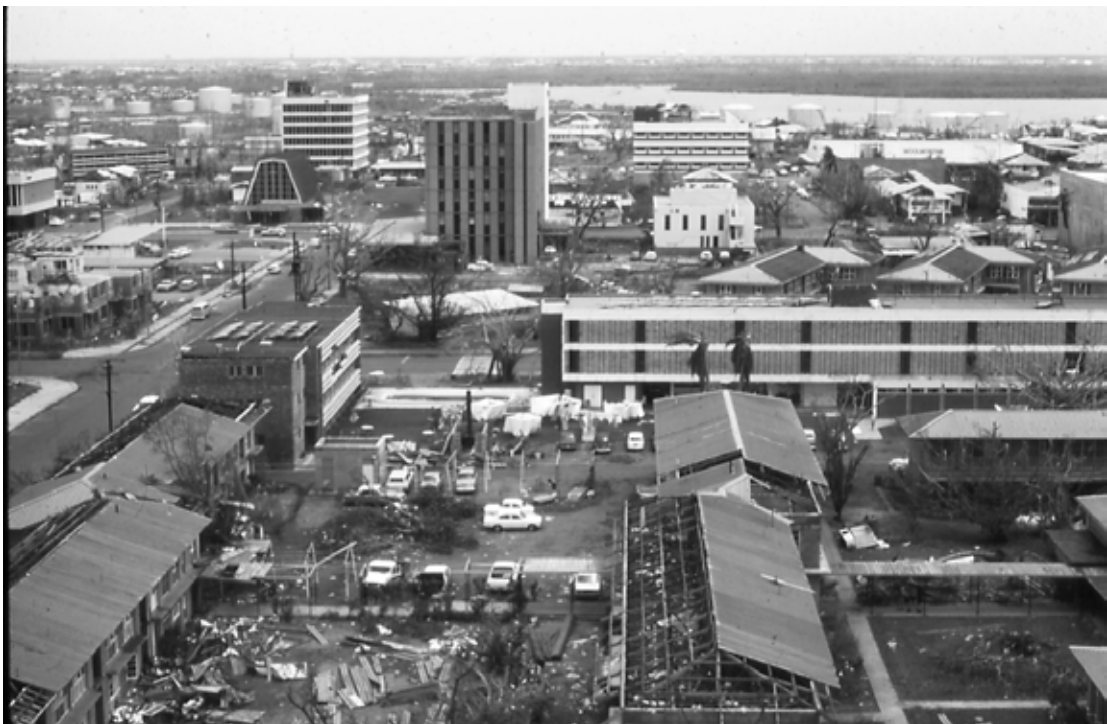
Fig 4.8 - Central City Area

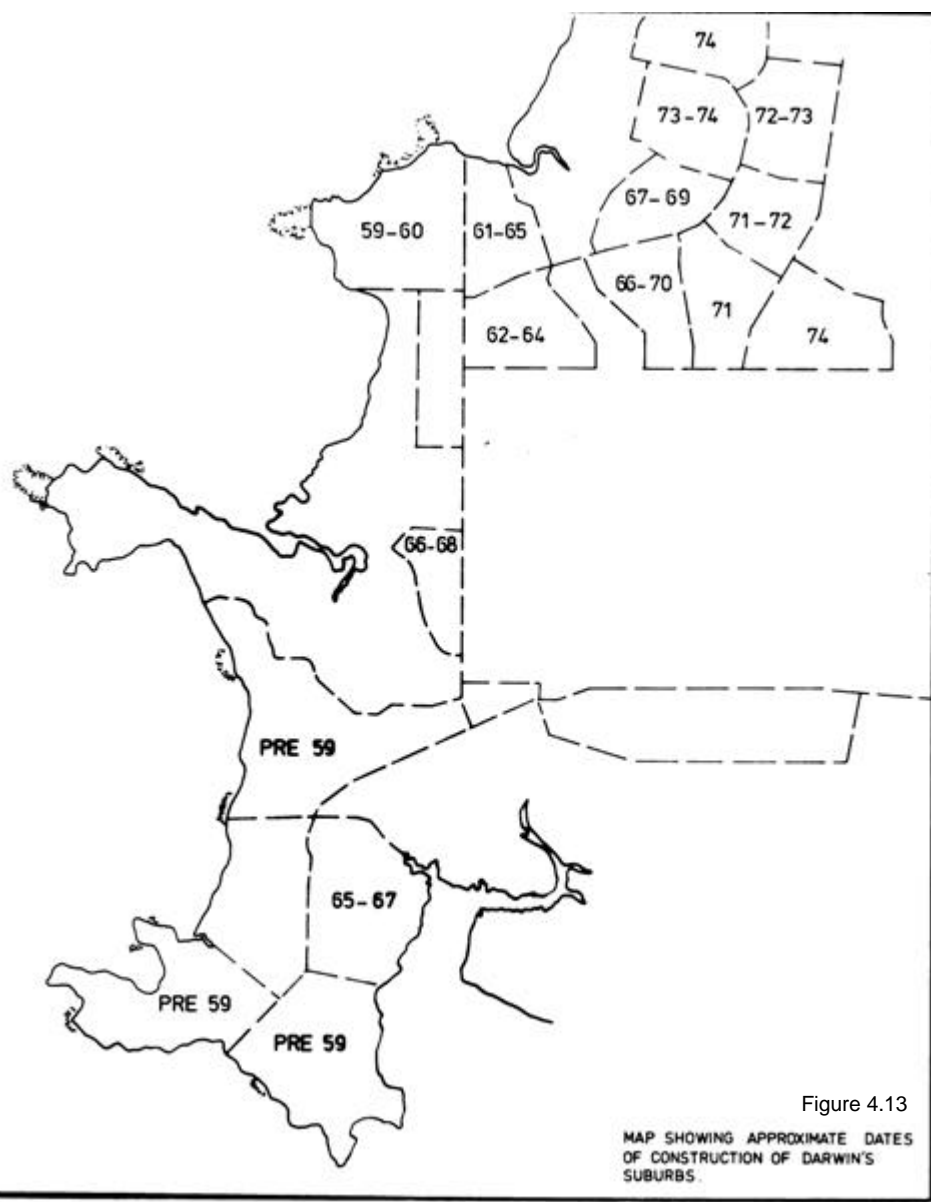
Traditional housing has undergone changes over the years and these changes may have influenced the damage pattern. Figure 4.13 shows the approximate date of construction of each suburb and comparison of this with the damage pattern shown in figure 4.9 shows that there appears to be considerable correlation between damage and age, with the degree of damage increasing the more modern the suburb.

MAP SHOWING APPROXIMATE DATES OF CONSTRUCTION OF DARWIN'S SUBURBS.

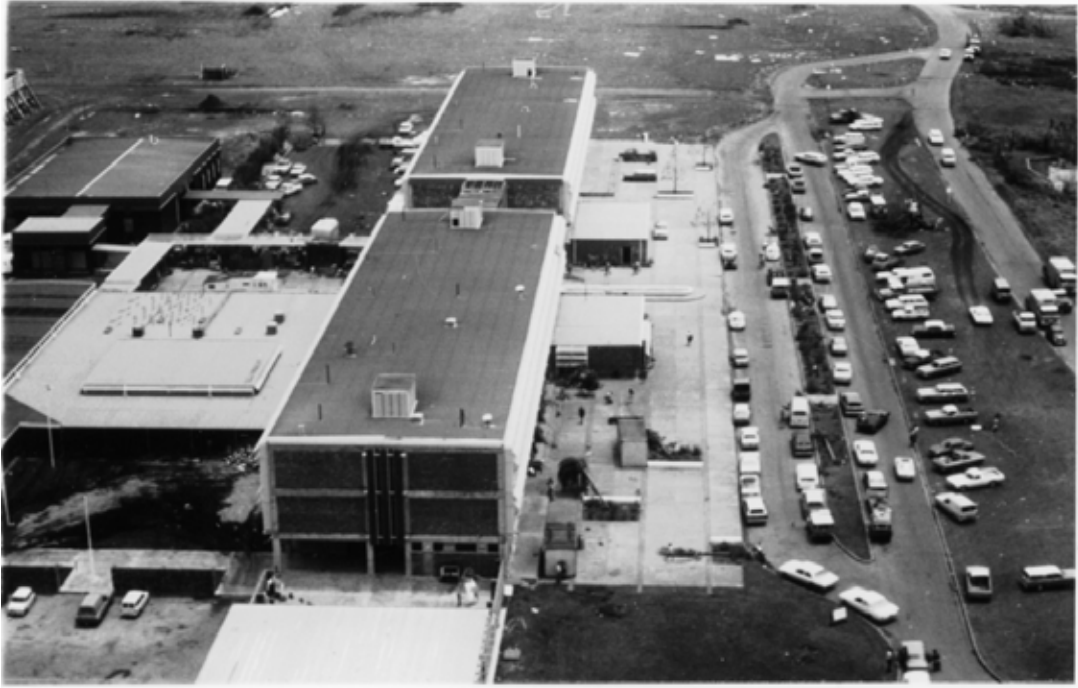
On large buildings the performance of roof cladding appeared to be markedly better than on small buildings such as houses, flats and small shops, despite the fact that the fastening in many cases did not appear to be any better – see figures 5.5 and 5.6.

Fig. 5.5 - Darwin High School

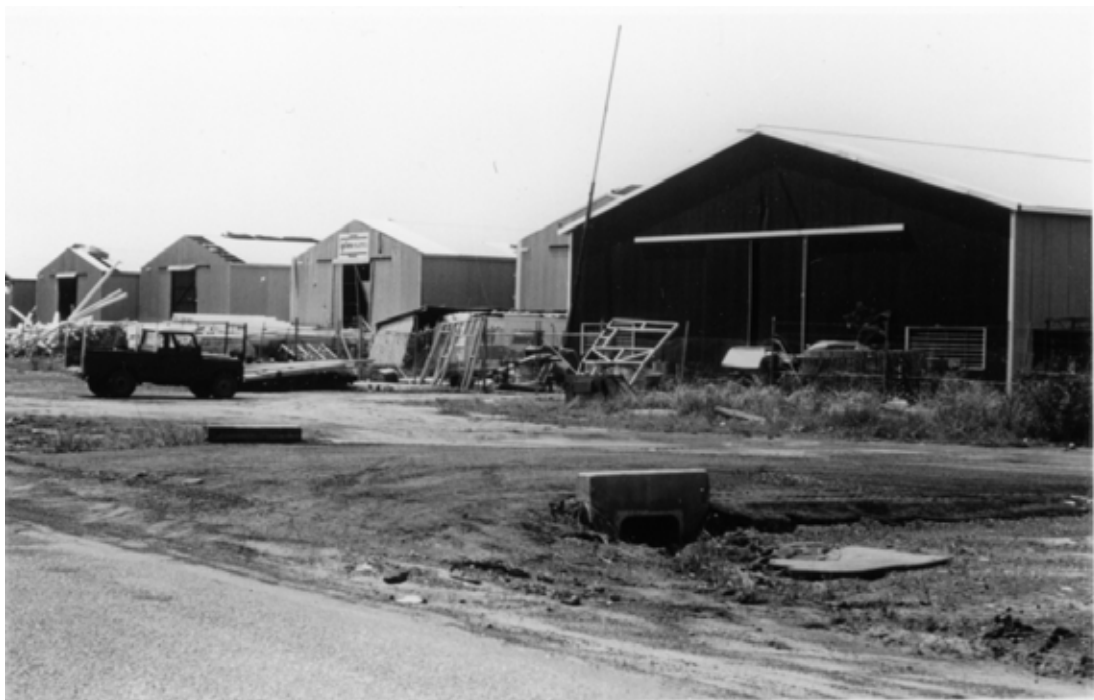
Fig. 5.6 - Typical industrial buildings

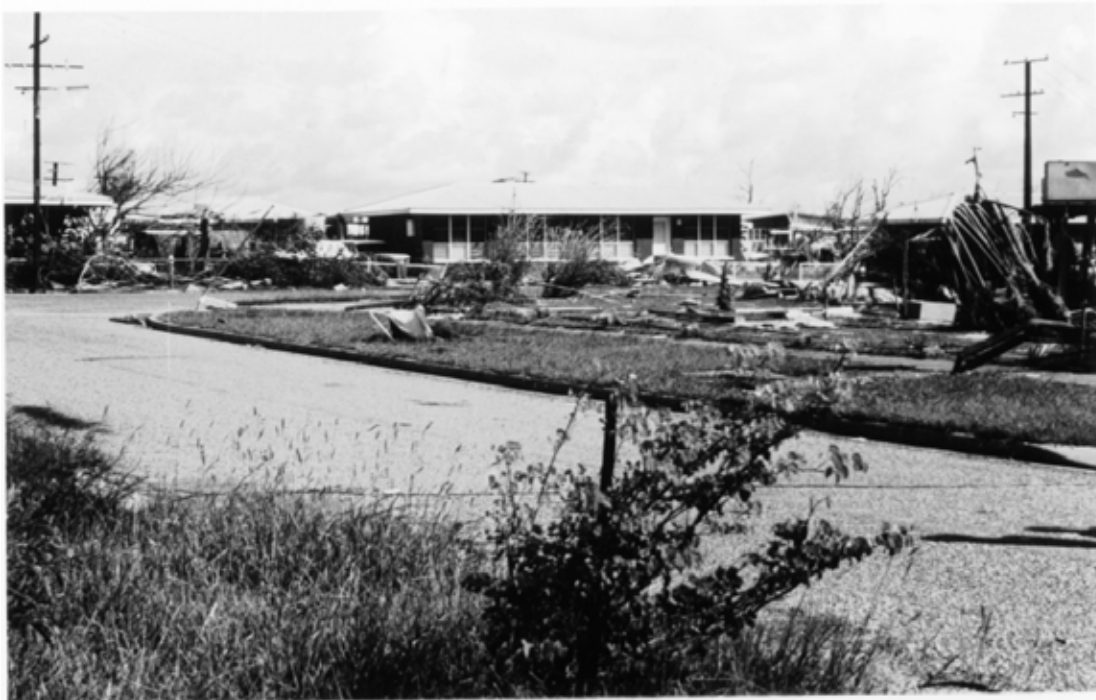
These houses performed very well in cyclone “Tracy” and formed a significant proportion of the undamaged and repairable homes – see figure 5.13. The most common failure was loss of roof cladding, quite often with the purlins as well. Lifting of the bond beam with subsequent damage to brickwork where it was anchored down at the corners was the most common form of more serious damage but overall it would appear that less than 10% of the homes in this group were damaged beyond repair.

Fig. 5.13 - Low set cavity brick construction

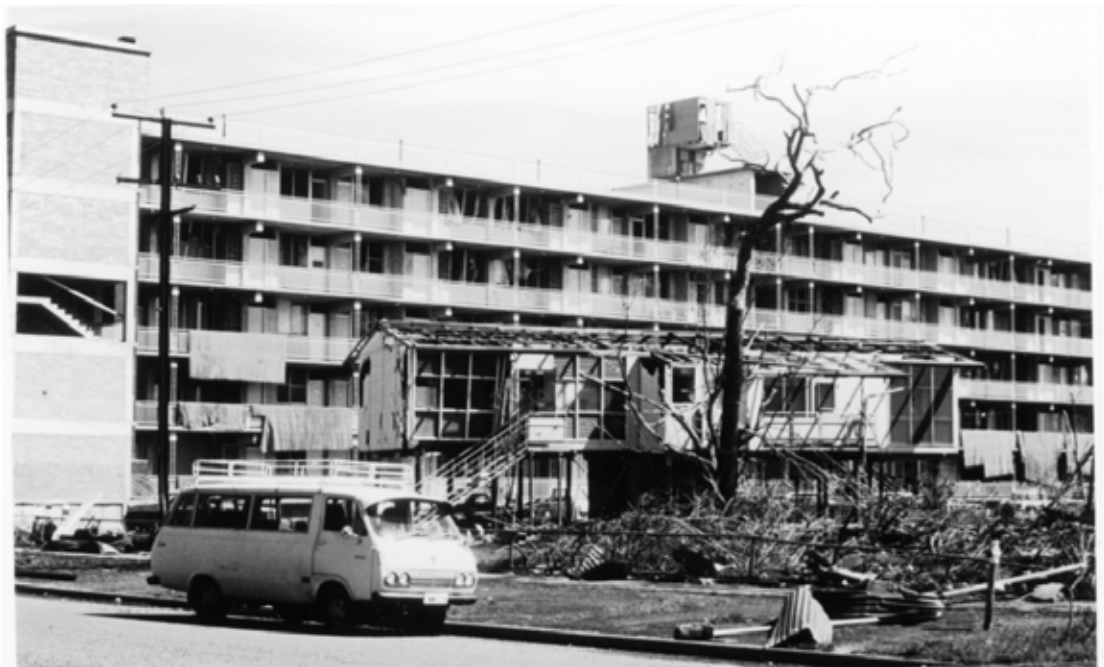
A block of flats incorporating an insitu concrete roof was conspicuous by its good performance – see figure 5.19.

Fig 5.19 – Flats which performed well

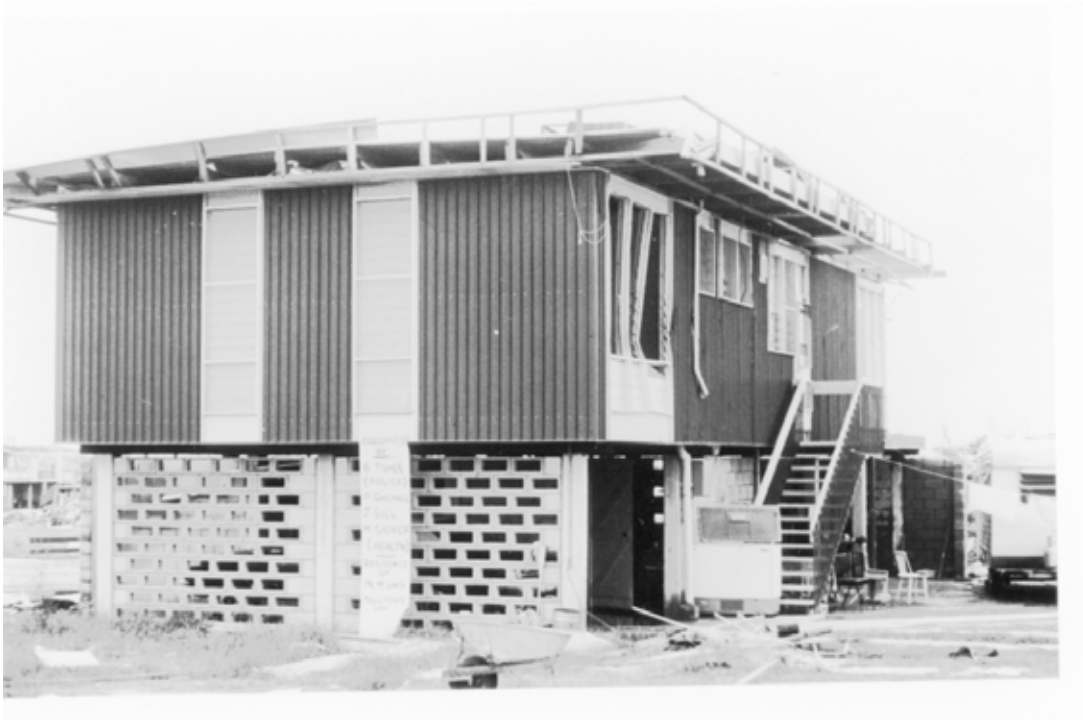
A more recent innovation has been the use of ribbed metal decking screwed on to the timber or metal framing and this cladding appeared to perform very well showing considerable capacity to absorb the impact of debris – see figure 5.24.

Fig. 5.24 - Metal clad house

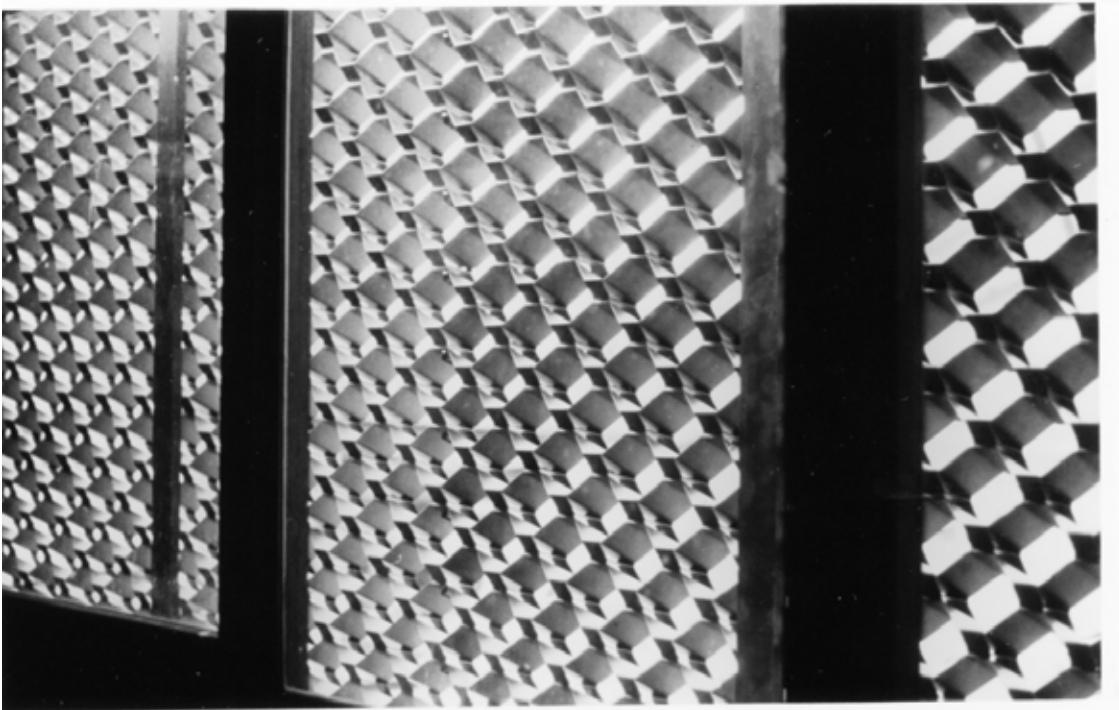
On a number of larger buildings, in the city area in particular, a considerable amount of sun screening had been incorporated. Light gauge metal louvre types performed relatively poorly where exposed on the windward face, but well constructed screen block and expanded metal cladding was observed to perform comparatively well, providing considerable protection to the windows in so doing – see figure 5.25.

Fig. 5.25 - Sunscreen protected windows

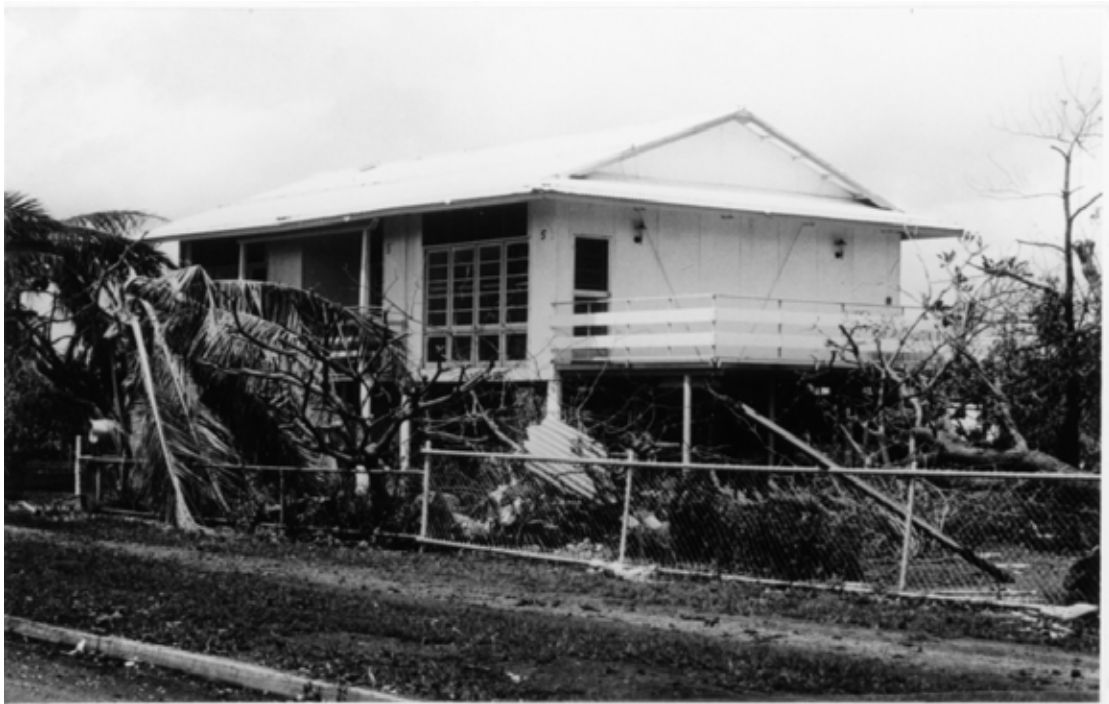
Figure 6.3 shows a house in Darwin which had been modified in this way and which testified to the usefulness of the method. Houses in the immediate vicinity suffered considerable damage and destruction and as figure 6.4 shows this house was severely holed in the end wall producing a very critical situation for the roof. It seems fairly certain that the owner can thank the battening for still having a house with a roof on – even it is a little distorted. It is interesting to note that proposals were in hand in Darwin for strengthening a large number of residences of this type by a similar method at the time of the cyclone.

Fig. 6.3 - Performance of house strengthened with battens over the top of the roof
