Chapter 2

Morphological Aspects of Fatigue Crack Formation and Growth

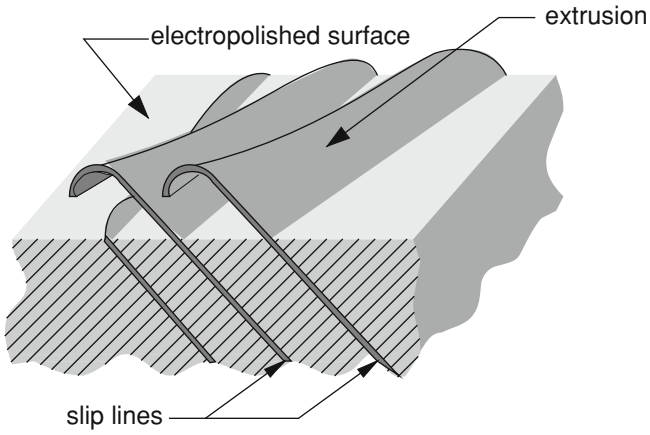
Fig. 2.2 Schematic of extrusions in copper according to Forsyth

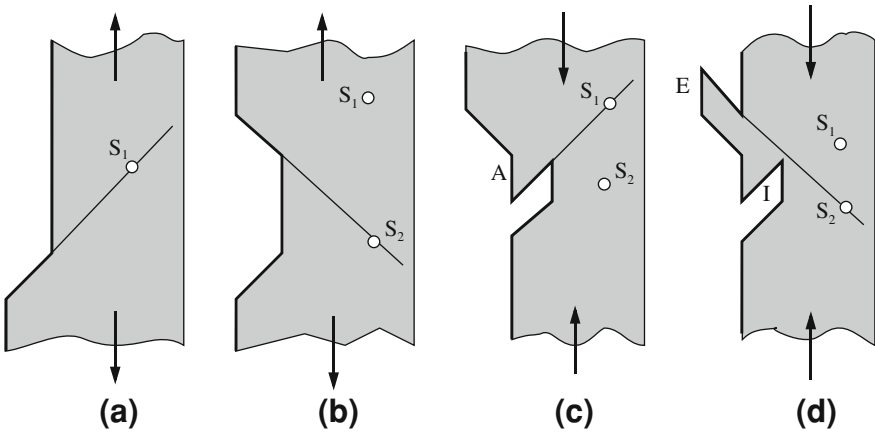
Fig. 2.3 Schematic of extrusion intrusion formation according to Cottrell and Hull

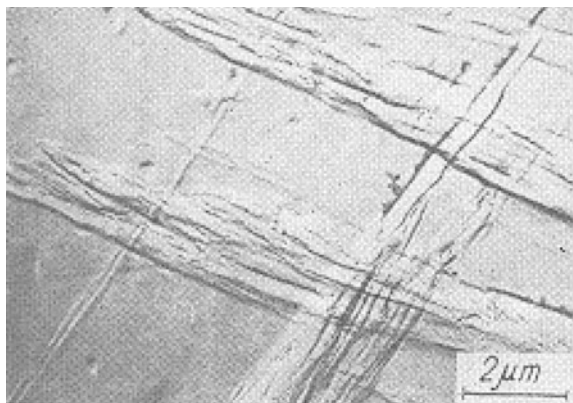
Fig. 2.4 Evidence of intersecting slip bands and cross slip in an Armco iron [10]

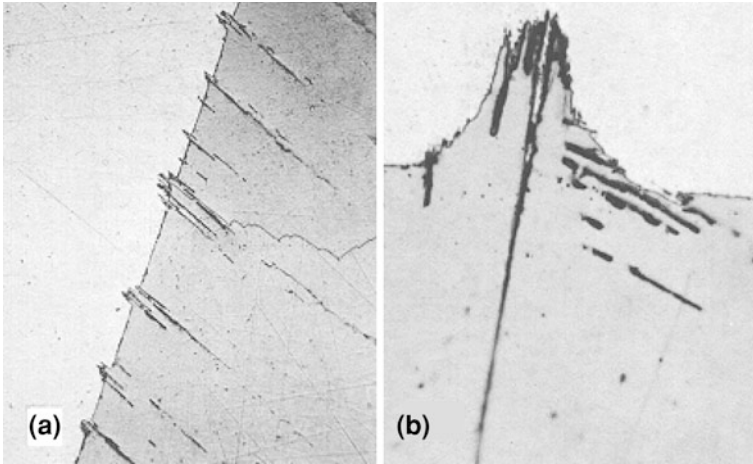
Fig. 2.5 Extrusions observed in **a** a copper specimen and in **b** Fe-3 Si [12]

of extrusion-intrusion formation activated by screw dislocations was proposed by Mott [11]. An example of extrusion in copper and Fe-3 Si is offered in Fig. 2.5 [12]. Note that there is a difference in the appearance of slip bands in copper and Fe-3 Si. Copper exhibits wavy glide while Fe-3 Si exhibits more planar glide (see Fig. 1.44). Alloys of low stacking fault energy, such as Cu-7 Al, also develop slip bands that resemble those in Fe-3 Si rather than those in copper. It can be seen the loss of surface smoothness and the crack formation associated with extrusions. Another example of extensive extrusions formation in copper under low cycle fatigue can be seen in Fig. 2.6 [9].

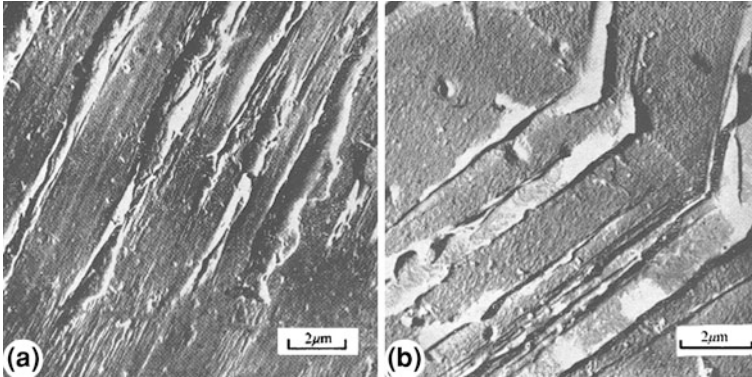
Fig. 2.6 Extrusions formation in copper under low cycle fatigue [9]

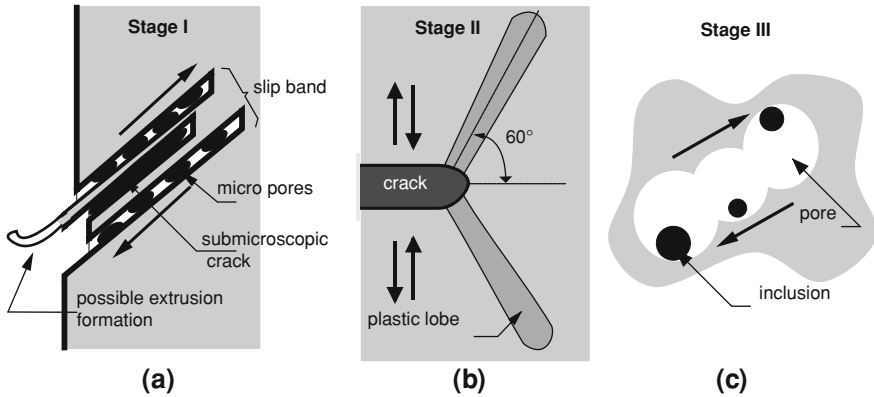
Fig. 2.7 Schematic of morphological models of **a** Stage I, **b** Stage II and **c** Stage III of fatigue

From a phenomenological point of view Stage I of fatigue can be described as a back and forth slip on a series of contiguous crystallographic plane to form a band (see Fig. 1.42). Bands so formed have, generally, height of the order of many hundreds of Angstrom. It is within this slip bands that the process of pores nucleation and coalescence, already described in the previous paragraphs, develop. The process eventually leads to micro cracks formation. Often, extrusion and intrusions may also appear which, being a very localized discontinuity, results in a much faster micro crack formation, as schematized in Fig. 2.7a. Micro cracks join to form a macro crack in Stage II of fatigue. Now the crack is already long enough ($>300 \mu\text{m}$) to escape shearing stress control and be driven by normal stress which produces a continuous growth, cycle by cycle, on a plane that is no longer crystallographic, but rather normal to external loads. Ahead of this macro crack two plastic lobes are generated by stress concentration, as shown in Fig. 2.7b. Even though these lobes are produced by shearing stresses they are orientated at about 60° with the crack plane, and not 45° . Effectively, LEFM tell us that a surface edge crack in a plate in tension generates two lobes the 60° with crack plane. Figure 2.8

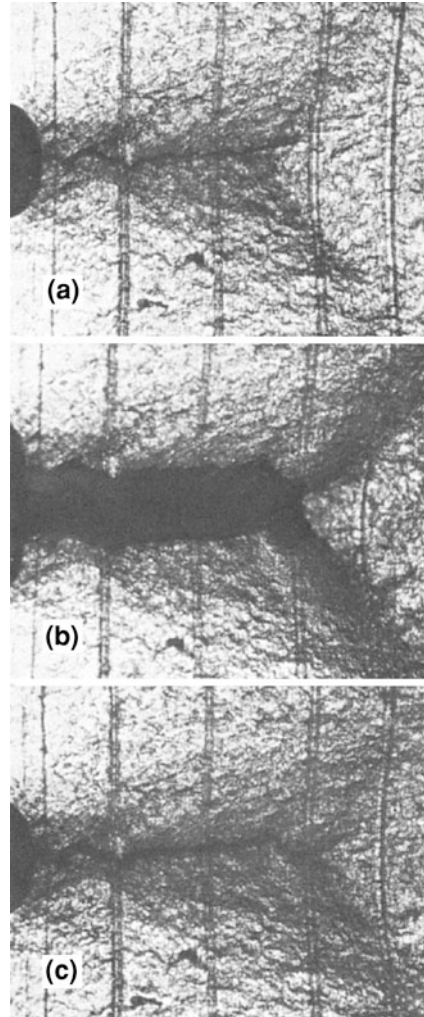
Fig. 2.8 Crack tip deformation (lobes) during loading sequence [14]: **a** after compression, **b** after extension, **c** again after compression

[14] shows such crack tip lobes produced under cyclic loads. The sequence starts from compression where the crack is closed, Fig. 2.8a. During successive traction, the crack opens and grows generating the two lobes at the tip, Fig. 2.8b. Next compression recloses the crack. This process leaves some characteristic markings on the fracture surface that will be possible to detect at high resolution in a SEM analysis. These markings are called striations and will be analyzed later. Finally, Stage III that concludes fatigue growth may happen in two steps. In the first, crack continues to grow by fatigue, but the driving stress field increases continuously because the remaining ligament ahead of the crack decreases. Fatigue, even when it starts as high cycle fatigue, becomes a low cycle fatigue and again shearing stresses become the driving stress, but this time crack growth doesn't proceed on crystallographic planes, but simply in a direction at 45° relative to the maximum stress, as explained in Sect. 1.5.2 (see Fig. 1.67). A schematic of this low cycle crack propagation process was given by Forsyth for aluminum alloys [15] and presented in Fig. 2.9. If there are enough cycles, fatigue, either high cycle or low cycle, terminates with the final failure of the resisting ligament, as shown schematically in Figs. 1.64 and 1.67. It takes just $\frac{1}{4}$ of cycle, the last, to trigger the collapse of the remaining section. When material behavior is ductile and not brittle, i.e. at least 30°C above the transition temperature for BCC materials, this final collapse develops through inclusion decohesion from the metal matrix forming cavities or voids, followed by cavities growth, coalescence and fracture, as shown in Fig. 2.10 [16]. In brittle materials final failure occurs by cleavage. From a morphological point of view fatigue crack propagation in Stage II may be transgranular or transcrystalline in high cycle fatigue or intergranular or intercrystalline in low cycle fatigue as shown in Figs. 2.11 and 2.12 [17], respectively. A rather comprehensive map of macroscopic appearance of possible fatigue failures in laboratory test specimens of various shape (cylindrical or prismatic) subjected to a wide range of different loading conditions, stress amplitude with or without stress concentration is offered in Fig. 2.13 [18]. The two characteristic

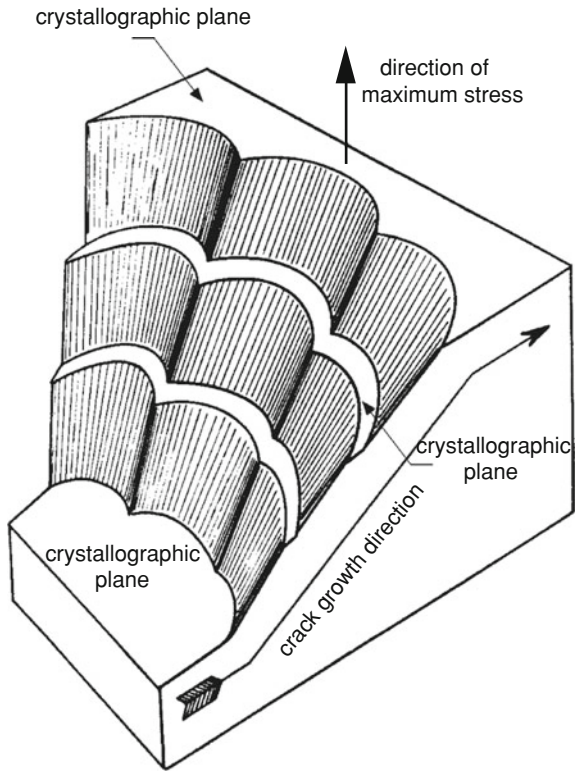
Fig. 2.9 Schematic of low cycle fatigue crack growth [15]. Crack propagation plane is not crystallographic and is inclined relative to the maximum stress

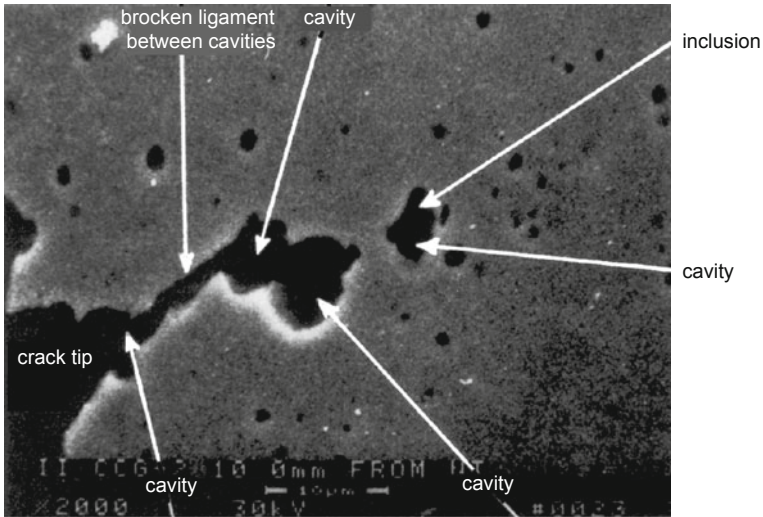
Fig. 2.10 Crack tip cavities formation and coalescence in a ductile fracture process (reproduced with permission of [16])

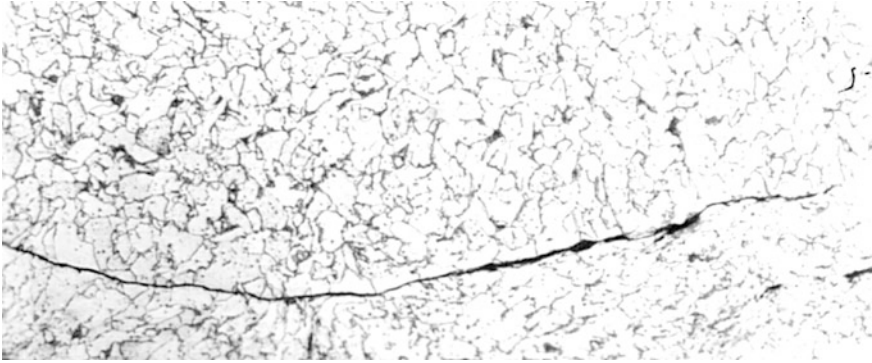
Fig. 2.11 Transgranular appearance of high cycle fatigue observed by Milella in low carbon steel

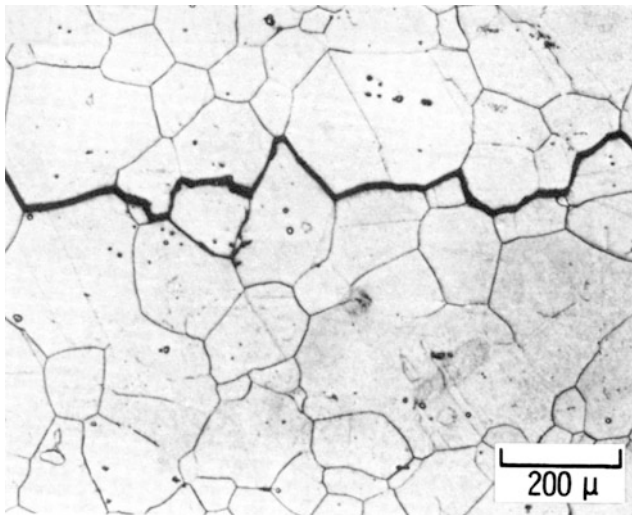
Fig. 2.12 Intergranular appearance of low cycle fatigue in Inconel X-750 at 650 °C [17]

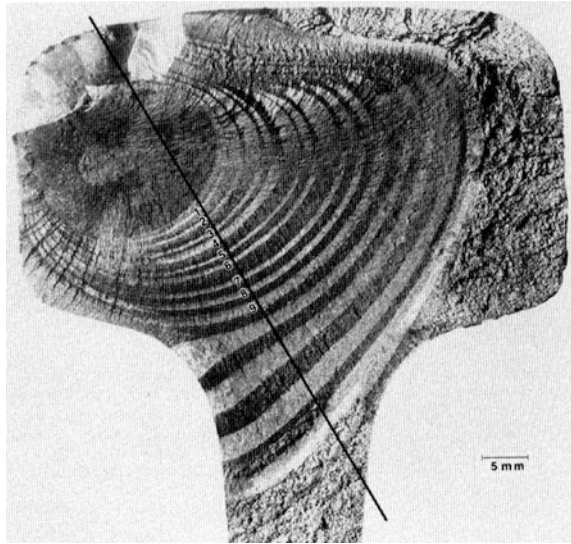
Fig. 2.14 Beach marks in the form of circumferential rings visible at naked eye on the head of a rail failed by fatigue [19]. The initial crack is the dark circle at upper left

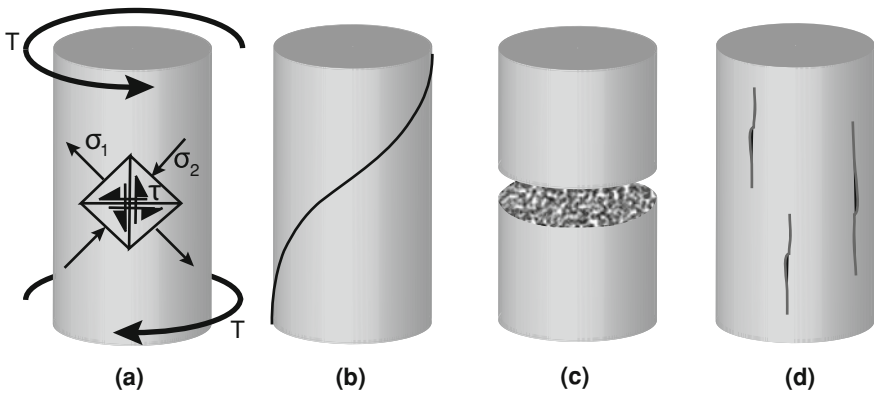
Fig. 2.15 Cylinder in pure torsion. **a** element free body stress state, **b** brittle behavior with helicoidally failure, **c** and **d** ductile failure activated by either longitudinal or transverse shearing stress

column in Fig. 2.13) or a flat failure if the material behaves in a ductile fashion. The difference may be understood analyzing the stress state as in Fig. 2.15. Under pure torsional moment any element free body taken at an arbitrary point on the surface is subjected to pure shearing stress acting on longitudinal and transverse direction, whereas principal stresses acts at 45° being traction on one face of the element and compression on the other, Fig. 2.15a. If principal stresses are high enough and the material is brittle the first macro crack formation will trigger a spiral fracture, Fig. 2.15b sustained by the principal traction stress. Conversely, in case of ductile behavior it may take shearing stress to develop a fracture along a normal plane, Fig. 2.15c, or axial, Fig. 2.15d. In this last case fissures will appear

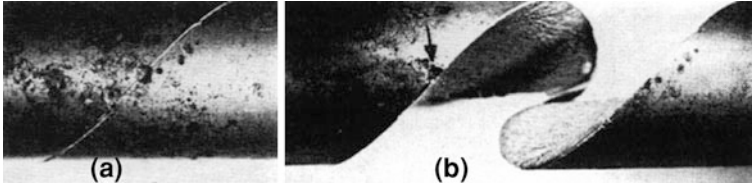
Fig. 2.16 Spiral fracture of a drive shaft of a scooter, starting at surface damage indicated by arrow [20]. **a** mating halves, **b** separated halves

on the surface parallel to the axial direction. An example of spiral fracture of a drive shaft of a scooter is shown in Fig. 2.16 [20]. The failure initiated at an inclusion indicated by the arrow. The second type of torsion failure (Fig. 2.15c or last row of Fig. 2.13, second case from the left) is shown in Fig. 2.17 [21]. It refers to an experimental 89 mm ($3\frac{1}{2}$ in.) diameter tractor axle of AISI 1041 steel that had been induction hardened. Note beach marks fanning out from the fatigue crack origin (slightly to left of center, at top). Beyond the beach marks cracking progressed by fast fracture along the hardened perimeter producing two sets of

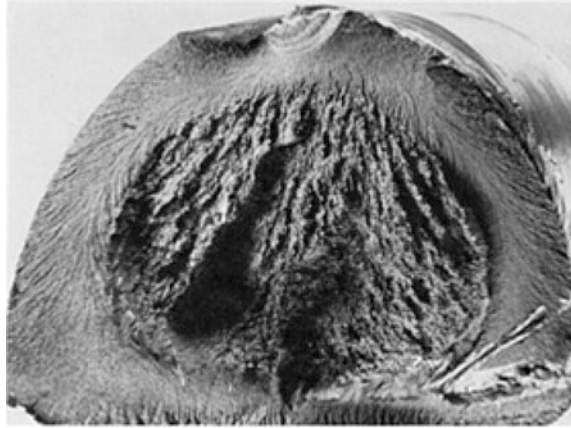
Fig. 2.17 Surface of a bending-plus-torsional-fatigue fracture in an experimental 89 mm ($3\frac{1}{2}$ in.) diameter tractor axle of AISI 1041 steel that had been induction hardened [21]

chevron marks pointing toward the crack origin. The central dark area represents the final fracture by overload.

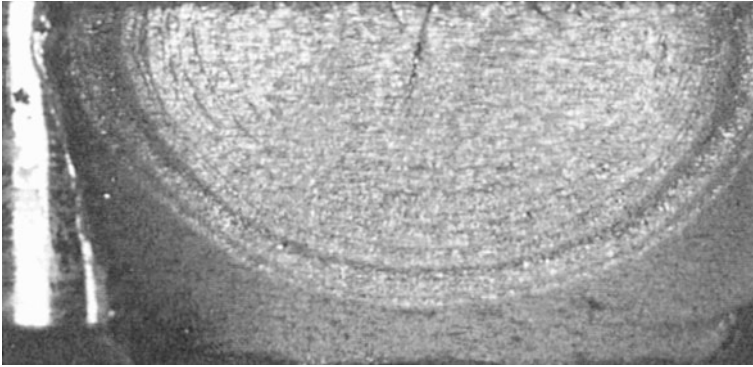
Fig. 2.18 Fatigue failure of a rectangular specimen of 7075-T6 aluminum alloy under unidirectional bending [22]

1. Fatigue failure in a specimen of 7075-T6 aluminum alloy of rectangular section under unidirectional bending of random amplitude, Fig. 2.18 [22]. Fatigue originated on surface metal fibers in tractions and propagated inside. The ratio $A_{\text{fatigue}}/A_{\text{collapse}}$ is definitely higher than 1 (A_{collapse} covers about 40 % of the total area) denouncing a high cycle fatigue with low stress amplitude. Beach marks of different depths are due to crack growth rate variation following random amplitude cycling.
2. Service fracture of 4130 steel shaft with sharp circumferential notch subjected to unidirectional bending fatigue, Fig. 2.19a [22]. Fatigue initiated on the lower part where metal fibers were in traction. Beach marks, due to oxidation when

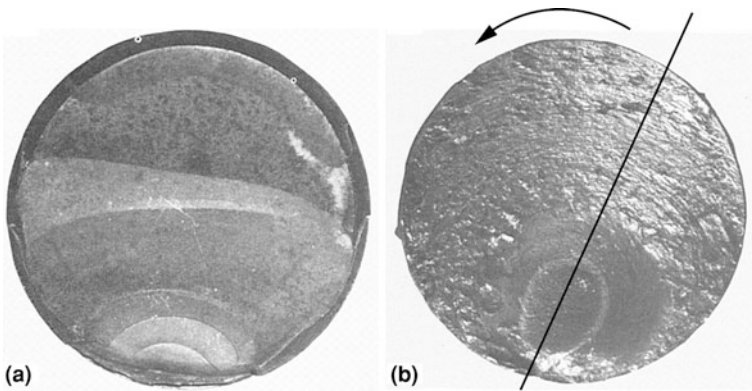
Fig. 2.19 **a** Unidirectional bending fatigue failure of 4130 steel shaft with sharp circumferential notch [22]. **b** Fatigue failure of 4150 steel shaft subjected to rotating bending [23]

material was idle, are initially concave and become wavy denoting final misalignment in load application. Fatigue has exceeded 50 % of section indicating relatively low amplitude stress.

3. Fatigue failure of 4150 steel shaft subjected to rotating bending, Fig. 2.19b [23]. The section shows beach marks over a large area of the fracture surface. Oval area near the bottom center is the final fracture area. Its major axis is oriented at about 20° relative to the direction of beach marks evolution. This feature indicates that the shaft was rotating in counterclockwise direction. The final area is about 10–15 % of the cross-sectional area which actually suggests low stress amplitude. Fatigue failure initiated at a point of stress concentration. Another example of rotating bending fatigue is that of Fig. 1.4 relative to a journal of an axle rail. Beach marks and the initiation site can be seen.

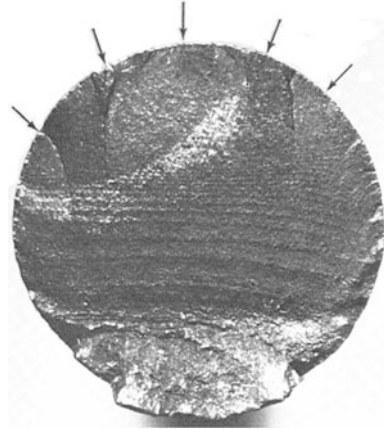
Fig. 2.20 High temperature fatigue failure under axial loads of a valve stem of 21-2 valve steel [24]. Note the ratchet marks around the circumference that denote the presence of multiple initiation sites (indicated by arrows)

4. High temperature fatigue failure under axial loads of a valve stem of 21-2 valve steel (21 % Cr, 2 % Ni, 8 % Mn, 0.5 % C, 0.3 N) in solution-treated and aged condition and faced with stellite 12 alloy (30 % Cr, 8 % V, 1.35 % C, rem Co), Fig. 2.20 [24]. Note the ratchet marks around the circumference that denote the presence of multiple initiation sites (indicated by arrows). The wavy shape of beach marks is indicative of off-axis load that has introduced a bending component.
5. Torsion fatigue failure of an axle of low carbon steel containing two holes, Fig. 2.21 [25]. Fatigue cracks initiated from holes that represent points of stress concentration. To feed the cracks has been traction principal stress acting on a plane at 45° to the axis (see Fig. 2.15a). The presence of two cracks at right

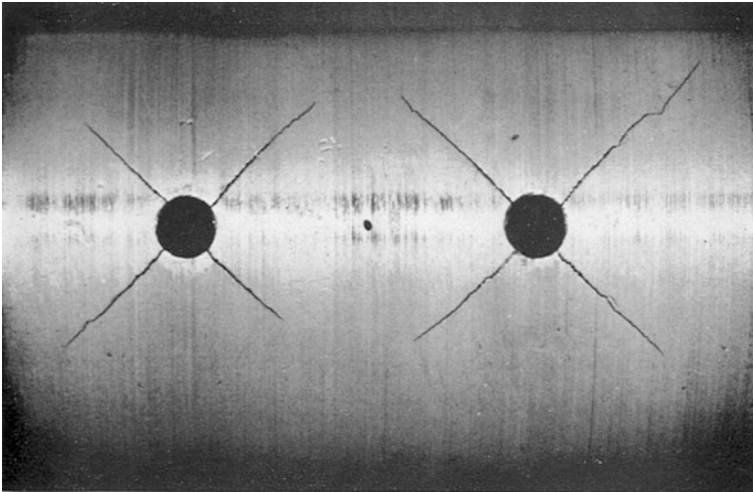
Fig. 2.21 Torsion fatigue failure of an axle of low carbon steel containing two holes [25]

angles to each other making an X suggests that the torque has been of a reversing character. Since the cracks are of approximately the same extent the indications are that the torque reversals have been of equal magnitude. This applies, however, only so long as the cracks are in a comparatively early stage of development, as beyond this stage one crack usually takes the lead and such inferences are no longer justified.

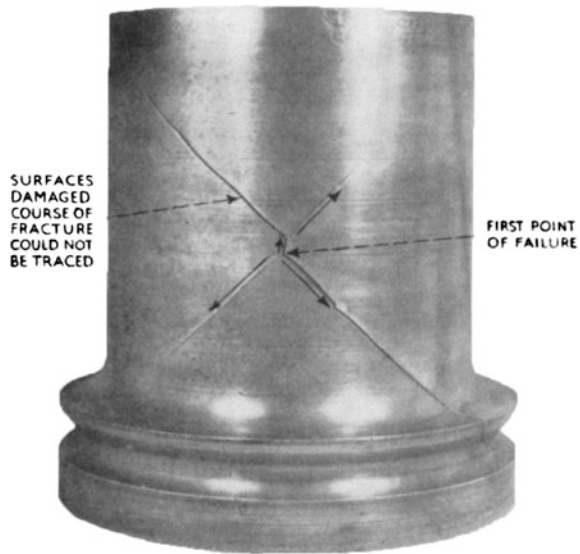
Fig. 2.22 Failure by torsional vibrations in an oil engine crankshaft [25]

6. Failure by torsional vibrations in an oil engine crankshaft, Fig. 2.22 [25]. Initiation started at the journal nearest the flywheel from a longitudinal inclusion afterwards cracks propagated along two X directions as in the previous case. Reversed bending failure in 1046 steel with a hardness of approximately HRC 30, Fig. 2.23 [26]. Rubbing has obliterated the early stages of fatigue cracking, but ratchet marks are present to indicate locations of crack initiation on both sides of the central region failed by overload that appear rougher than the fatigue areas.

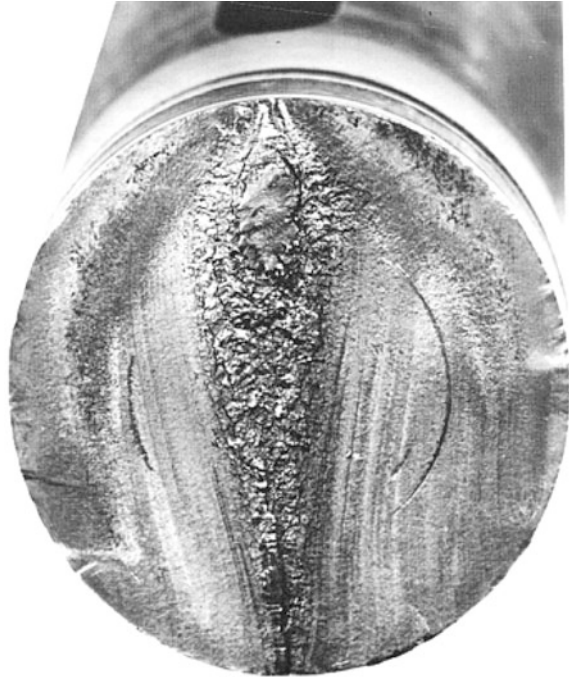
Fig. 2.23 Reversed bending failure in 1046 steel [27]. Rubbing has obliterated the early stages of fatigue cracking. Ratchet marks along circumference indicate locations of crack initiation

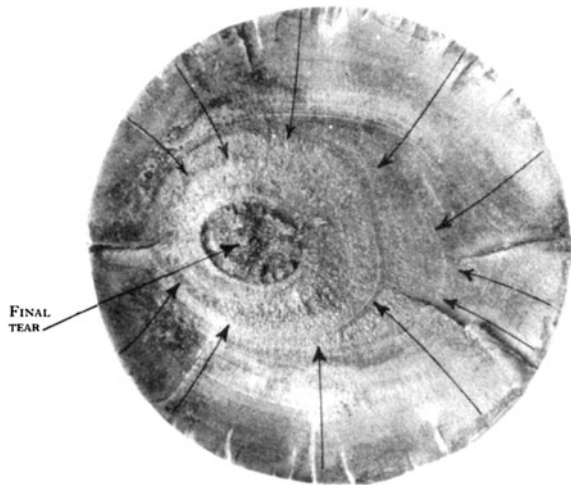
Fig. 2.24 Fracture surface of the piston rod of a pneumatic hammer failed under tension-compression loads [27]. The small radial ridges near the periphery show initiation sites that form several crack fronts that merged into a single annular one

7. Fracture surface of the piston rod of a pneumatic hammer, Fig. 2.24 [26]. It may seem a rotating bending failure because of the lateral center oval area denoting final fracture (see case 3 marks and Fig. 1.96b), but it is not. The cracks were caused by tensile stresses developed due to non-axial loading, which were probably supplemented by compressive stress waves that became tensile when reflected. The small radial ridges near the periphery show that a series of cracks broke out there and joined together to form several crack fronts separated by the large ridges; ultimately, the crack fronts merged into a single annular one surrounding the zone of final failure.

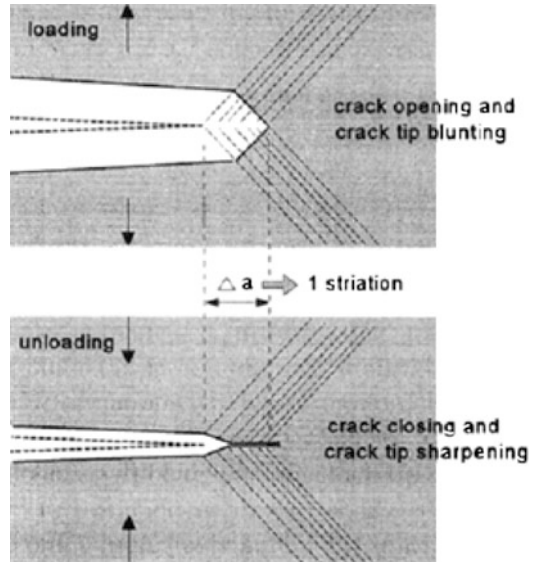
Fig. 2.25 Crack tip blunting and growth in during loading and closure upon unloading and closure upon unloading that leads to striation formation through the crack tip plastic slip mechanism [30]

eye, the trace of a single cycle can be seen only at high magnification, like in optical or better SEM or TEM analysis. This trace was originally called slip band by Thompson e Wadsworth [28] and later striations by Nine e Kuhlmann-Wilsdorf [29]. Striation is the most striking fine scale feature left on the fatigue surface, a kind of microscopic fingerprint that identify fatigue crack growth. The reference basic model in striations generation is that of crack tip plastic slip schematically shown in Fig. 2.25 [30]. During loading phase the crack is opened by normal stress that activates plastic slips at the tip. Fracture mechanics is predicting that this flow happens along two symmetrical directions (see Figs. 2.7b and 2.8). In this phase crack tip blunts and grows by material decohesion associated to dislocations flowing into the tip or generated by stress concentration. This type of plastic deformation is not completely recoverable. Therefore, upon unloading the blunting is squished, but a new free surface remains head of the former crack with a new sharp tip. The irreversible process has made the crack grow by a quantity Δa . It is this step by step process of blunting and re-sharpening at each cycle that leaves on the crack path a kind of footprint that we call striation, as schematized in Fig. 2.25.

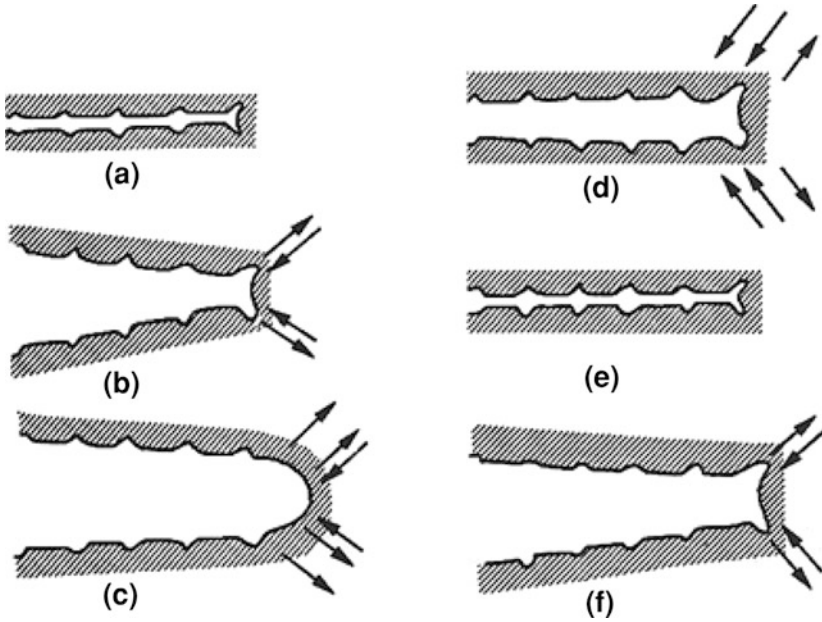
Fig. 2.26 Schematic of striations formation based on crack tip plastic relaxation [31]

Laird has given a rather different interpretation of striation formation based on the so called plastic relaxation of crack tip that is schematized in Fig. 2.26 [31]. Figure 2.26a refers to initial condition where crack is idling. Then the load is applied, Fig. 2.26b and crack tip plastic slips occur on both sides. At maximum load, Fig. 2.26c, the tip is fully blunted. With load inversion, Fig. 2.26d, crack tip closure takes place by reverse plastic flow that leaves the crack in the same initial condition, but with a new formed elementary free surface that testifies the crack growth, Fig. 2.26e. Last stage, Fig. 2.26f, represents the new loading phase similar to (b). Note that the process, that Laird called plastic relaxation, is based on the

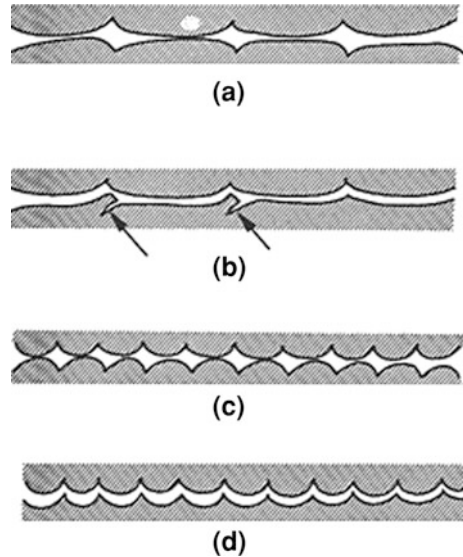
Fig. 2.27 Possible crack propagation profiles according to Laird's model of striations formation [31]

hypothesis of plastic collapse of crack tip during the unloading and closure phase that leads to tip concavity. Some characteristic profiles associated with crack propagation in Stage II of fatigue and to the above mechanism of fatigue formation are shown in Fig. 2.27 [31]. The first, Fig. 2.27a, indicates a fatigue propagation under relatively high stress amplitude, yet lower than yield strength. It consists of mating concave-convex parallel profiles on the two opposite fracture surfaces. Type (b) is characterized by the presence of small lateral cracks, indicated by arrows, and is characteristic of brittle striation, which will be discussed later. Types (c) and (d) are similar to type (a), but the smaller dimension of depressions indicates lower stress amplitudes. Types (a), (c) and (d) striation are called ductile striation since they are based on one of those mechanisms just seen that are based on crack tip plastic slip.

An example of ductile striations of the type presented in Fig. 2.27a, c and d is shown in Fig. 2.28a [15]. They were observed by Forsyth on 7,5 Zn-2,5 Mg aluminum alloy. The brittle case of Fig. 2.27b is shown in Fig. 2.28b and c [15]. The material is always 7,5 Zn-2,5 Mg aluminum alloy. In this case the micro cracks emanating from each propagation step can be seen. Figure 1.106c shows

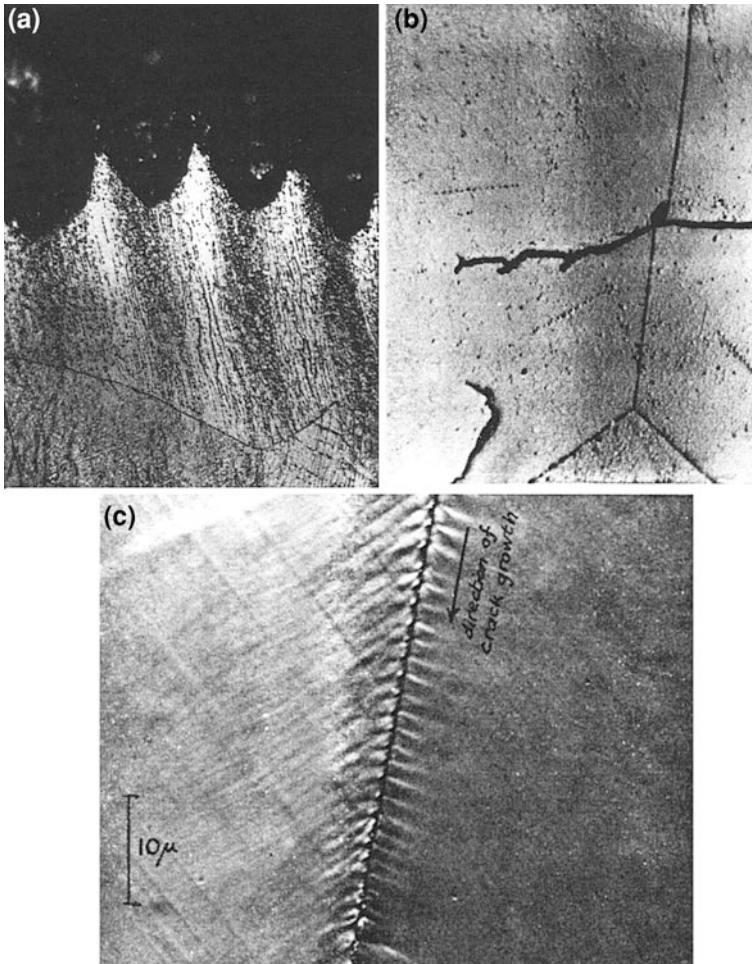
Fig. 2.28 **a** Ductile. **b** brittle striations observed by Forsyth on 7.5 % Zn–2.5 % Mg aluminum alloy [15]. **c** plastic enclaves observed on a free surface associated with brittle striations [15]

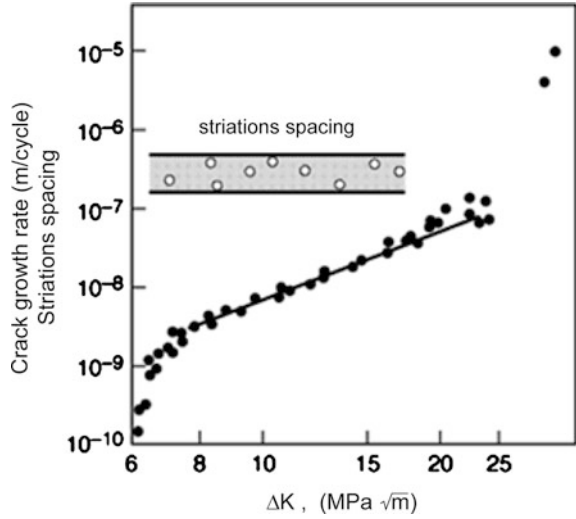
Fig. 2.29 Fatigue crack growth rate (circles and line) versus stress intensity factor ΔK in annealed iron in humid air. Also shown are the striations width measurements [32, 33]

Grinberg has been the first to recognize that the minimum striation size was in the order of a tenth of a micron, from one to three orders of magnitude higher than the real growth per cycle, as shown in Fig. 2.29 for an annealed iron in humid air [33, 34]. This has been recognized in Aluminum and its alloys, magnesium, nickel, titanium alloys and many steels. Figure 2.30 shows striations observed by Milella on carbon steel type Fe 510 in the threshold zone. Striation width is about $0.1\text{--}0.2 \mu\text{m}$, but the real growth rate should be $10^{-4}\text{--}10^{-3} \mu\text{m}/\text{cycle}$, i.e. from one thousand to one hundred folds lower. On a microscopic scale fatigue crack propagation evolves on different planes. This is due to metallurgical reasons and, in particular, to the fact that fatigue crack propagates along grains that are not necessarily coplanar, as schematized in Fig. 2.31 [35]. Striation are grouped in areas of homogenous propagation separated by tear ridges in which material fails by shearing resulting in the apparent continuity of the fatigue advancing front. The areas of homogenous propagation represent single grain. The various propagation areas may join as, for example, 7 and 8, in Fig. 2.31, that merge into 9 or separate as 4 that bifurcates into 5 and 6. In each of these individual areas the crack propagation direction, indicated by arrows, may not be exactly the same.

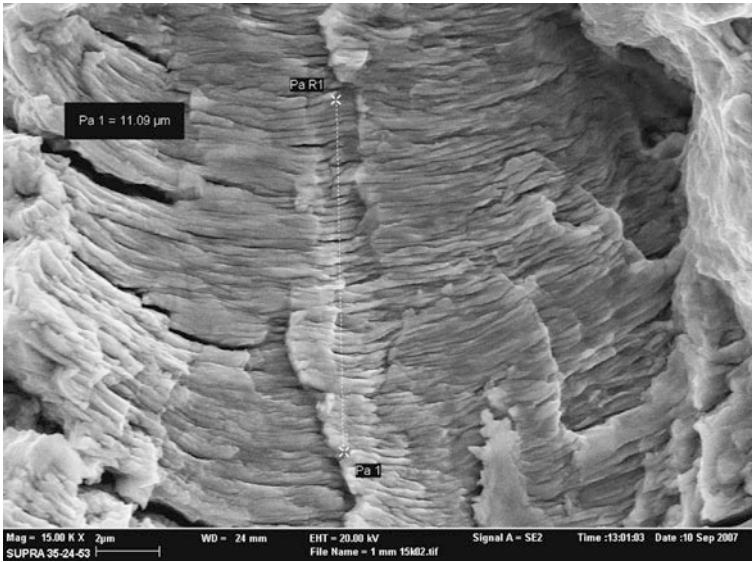
Fig. 2.30 Striations observed by Milella on Fe510 carbon steel in the fatigue threshold zone. Striations width is about $0.1\text{--}0.2 \mu\text{m}$, but the real growth rate is significantly lower, about two orders of magnitude

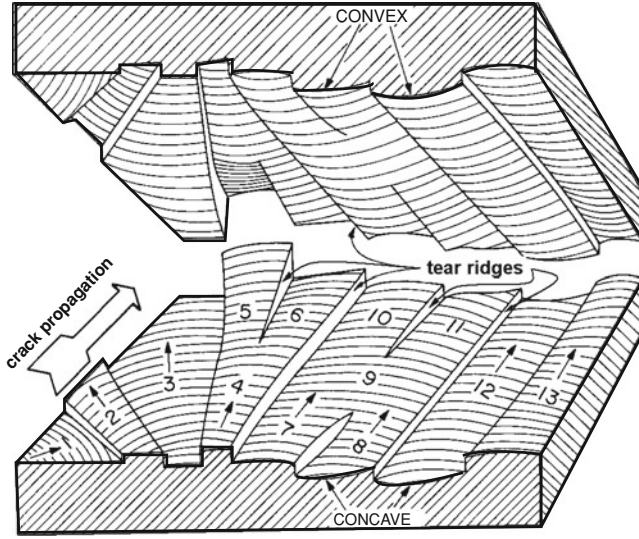
Fig. 2.31 Schematic of striation growth in grains and their merging or separation (reproduced with permission of [35])

Striations are always bowed out in the direction of crack propagation because their growth evolves more easily at center than on borders where they are blocked by grain boundaries and other barriers. Some areas of local propagation, as 7 and 13 in Fig. 2.31, are convex others, as 8 and 12, are concave on one side and the opposite on the other side thus forming the concave-convex mating surfaces and profile as shown in Fig. 2.31. It is rather common to observe areas of homogenous propagation separated by others that do not show any signs of fatigue, specifically striations. An example is shown in Fig. 2.32 for a 6Al–4 V titanium alloy [35]. It may also happen that during crack propagations the two mating surfaces slightly move relative to each other. This causes the loss of perfect mating between elevations and valleys that may results in a continuous hammering between pikes

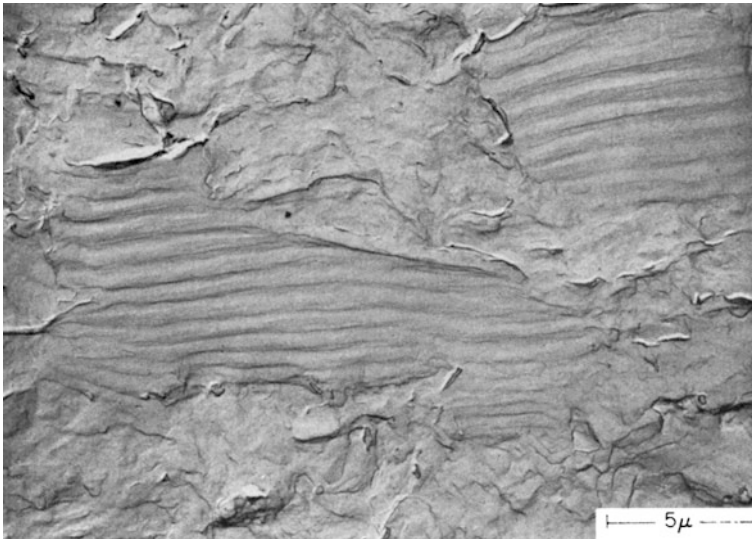
Fig. 2.32 Fatigue striations in 6Al-4 V titanium alloy [35]. Same area shows striations formation other doesn't

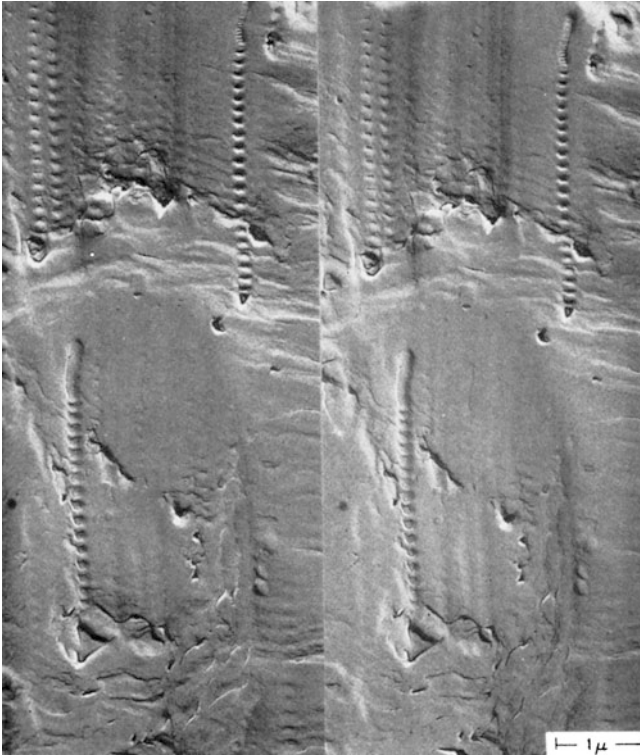
Fig. 2.33 TEM of 2024-T3 aluminum alloy showing characteristic tire tracks signs due to surface hammering [35]. Pair stereo replica

during the unloading phase. These signs, less or more marked depending on the relative surfaces offset, are called tire tracks. An example of tire tracks is shown in Fig. 2.33 for 2024-T3 aluminum alloy [35]. Another cause for tire tracks formation is the presence of hard particles that hammer opposite face, always due to surfaces

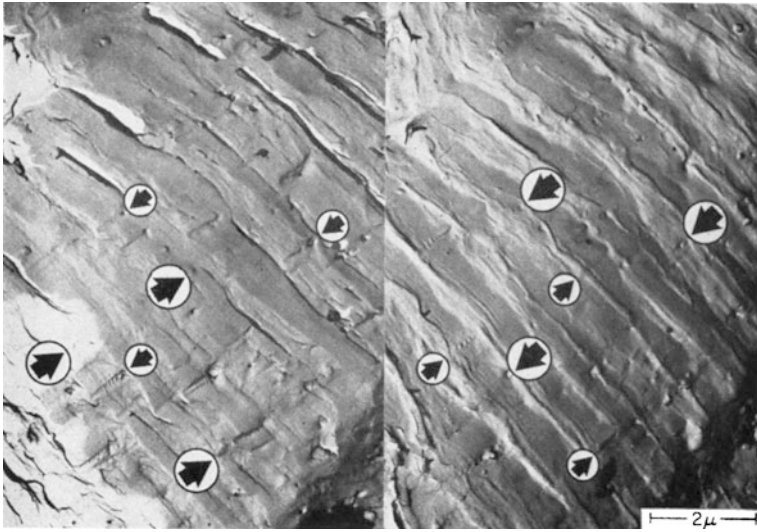
Fig. 2.34 TEM of 2024-T3 aluminum alloy showing characteristic tire tracks signs due to hammering operated by hard particles indicated by arrows on offset opposite surface (reproduced with permission of [35]). Pair stereo replica

offset. This is shown in Fig. 2.34 [35]. Quite often it may happen to see cracks between striations, as in Fig. 2.35.

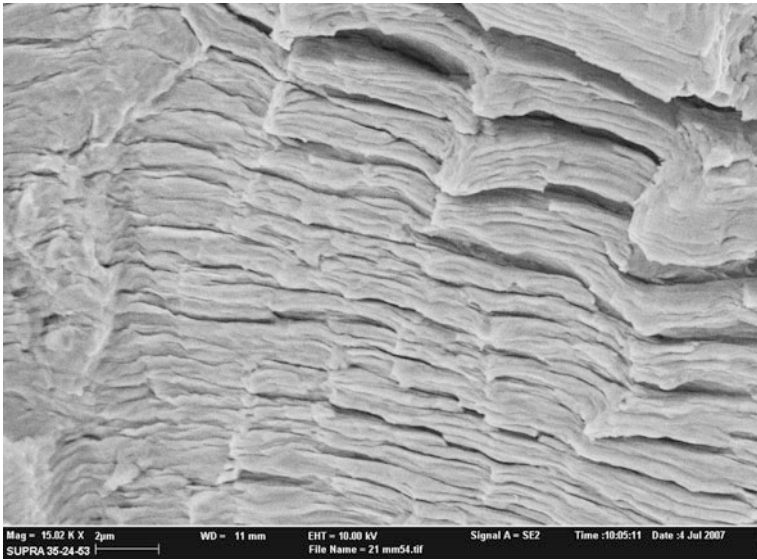
Fig. 2.35 Cracks between striations observed by Milella produced after the crack has passed ductile because the material ahead of crack tip undergoes plastic deformations that produce the typical curved arrays by which they advance on the fracture surface. Brittle striations, instead, develop always on crystallographic planes, usually (100)

Another characteristic feature that may be observed on each single striation, as in Fig. 2.35, is the presence of smaller closely spaced striations. The origin of these closely spaced striations may be explained by the striation mechanism proposed by Gross and schematized in Fig. 2.36. In this mechanism, basically similar to that of Fig. 2.25 and based on two stages process of blunting and closure re-sharpening of the crack tip, compressive closure stress, Fig. 2.36b, may activate a series of slip lines ahead of the crack tip that leave a trace on the main striation.

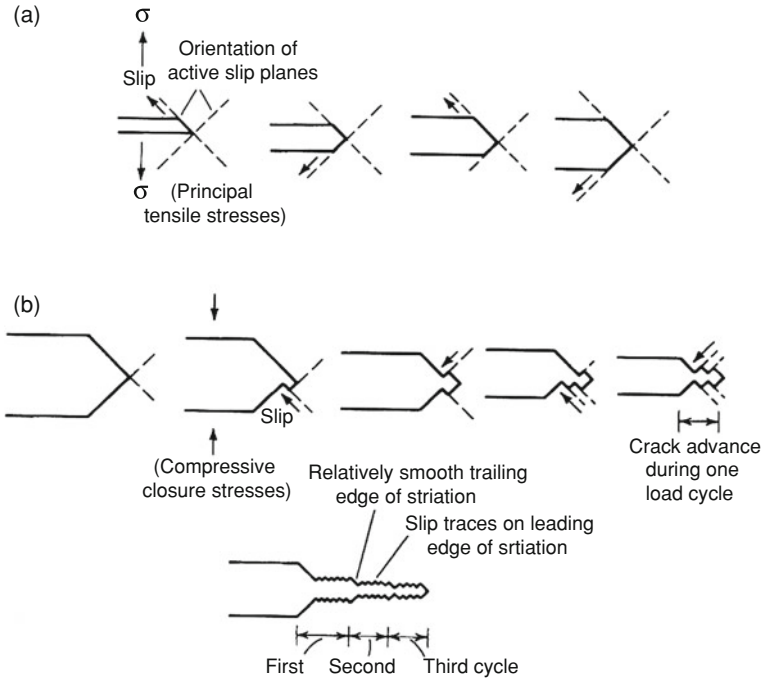
Fig. 2.36 Schematic mechanism of fatigue crack propagation by alternate slip at crack tip: **a** crack opening and crack tip blunting by slip. **b** crack closure and crack tip re-sharpening by partial slip reversal (reproduced with permission of [36]). Reprinted with permission of ASM international. All right reserved

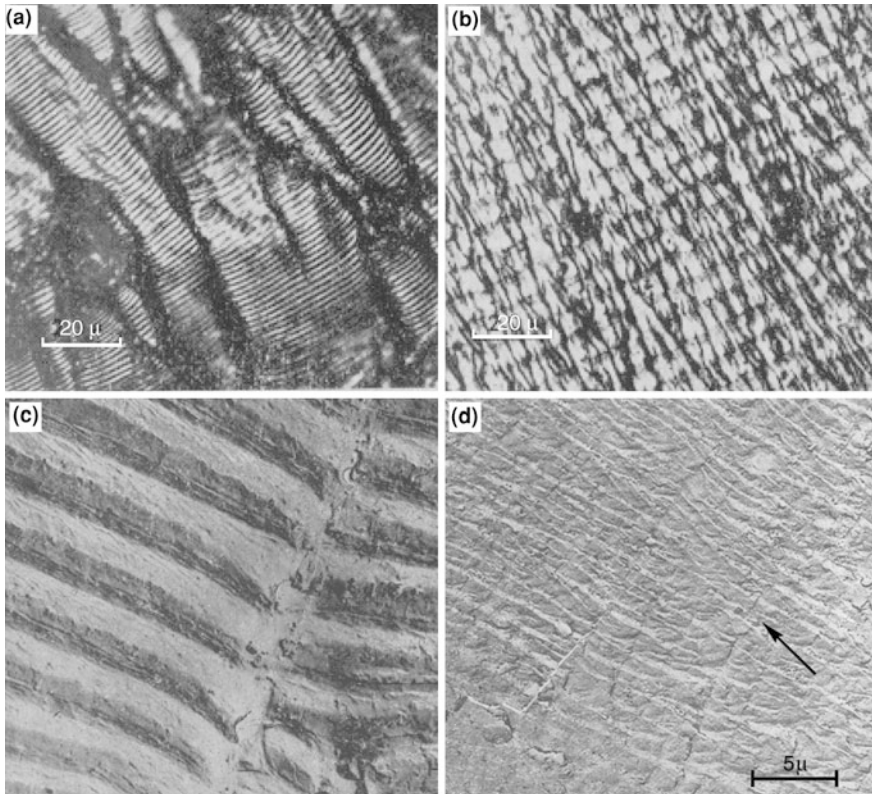
Fig. 2.38 **a** Ductile striations, **b** brittle striations on 7.5 Zn–2.5 Mg aluminum alloy, **c** ductile striations on 7178, **d** brittle striations on 2014 aluminum alloys [39, 40]. **a** and **c** observed with optical microscopy, **c** and **d** with TEM. *Note in b* the array of groves transverse to striations circles better identify in **d** as cleavage steps

planes [38], and appear as concentric circles departing from the initiation site, quite often brittle inclusions, Fig. 2.37b. This gives brittle striations the typical flat appearance with any apparent (macroscopic) plastic deformation. Brittle striations are always associated with corrosion assisted fatigue and, in particular, with hydrogen absorption, as it will be discussed in Sect. 16.4. Example of ductile and brittle striations are shown in Fig. 2.38 [39, 40] on 7.5 Zn–2.5 Mg, 7178 and 2014 aluminum alloys.

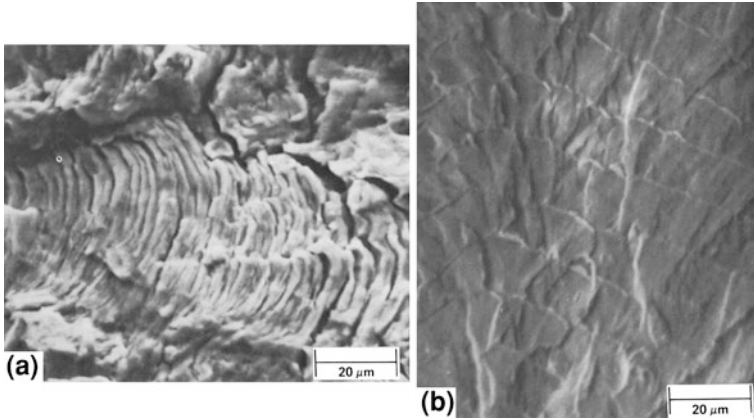
Fig. 2.41 **a** Ductile striations and **b** brittle striations developed in a ferritic low strength steel stressed **a** in dry air and **b** in hydrogen gas environment [42]

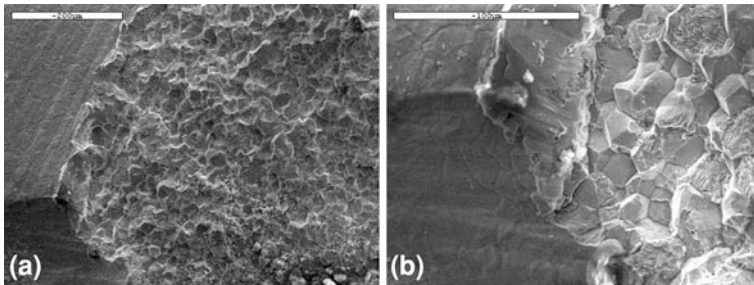
Fig. 2.42 **a** SEM morphology of intergranular fatigue failure of a gear tooth of NiCr steel hardened to HRC 55 observed by Milella. **b** detail of the initiation site

morphology of fatigue failure is so typical that any time an intergranular separation appears the first hypothesis made is always that of hydrogen embrittlement and in most cases it's the wrong one. Figure 2.42 is an example of this kind of fatigue failure observed by Milella on a 1,100 MPa NiCr high strength gear steel, hardened to HRC 55 that failed after 1,000,000 cycles with $R = 0$.

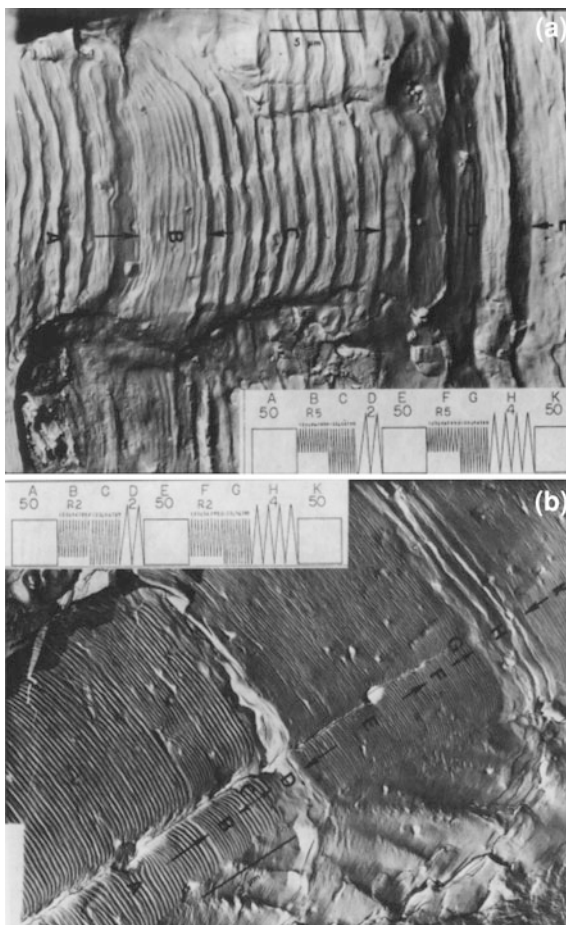
Fig. 2.43 Programmed loading fractography to evidence packages of fatigue cycles in 2124-T351 aluminum alloy [44]. Loading sequence *A*, *B* and *C* are repeated after being separated by overloads *D*. The number of cycles given in each block can be verified on the fracture surface by SEM analysis

and each striation had a width proportional to the corresponding cycle amplitude. An example of such a technique of programmed load fractography used by Pelloux et al. on 2124-T351 aluminum specimens is shown in Fig. 2.43 [44]. The loading sequence A, B and C programmed in number and amplitude of cycles is repeated after an overload of two or four cycles. Each block of cycles is clearly detectable by SEM fractography analysis. The two and four overload markers can be identified on the fracture surface.

The number of cycles applied in each block is equal to those counted on the fracture surface. The different striations amplitude is also evident and is proportional to cycle amplitude. Moving from high cycle fatigue to low cycle fatigue regime, striations gradually disappear giving place to fractographic signs similar to those that characterize ductile fracture, according to what has been said about Stage III of fatigue in § 1.7. A clear example is shown in Fig. 2.44 [45] for 6061-T651 aluminum alloy. Figure 2.44a refers to Stage I damage nucleation phase almost featureless at low magnification. Figure 2.44b shows the region of crack

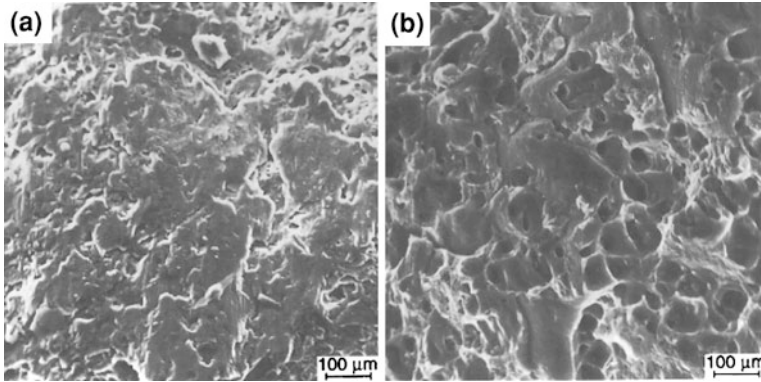
Fig. 2.44 SEM analysis of the fracture surface of 6061-T651 aluminum alloy failed by low cycle fatigue showing: **a** featureless crack initiation region, **b** voids and intergranular cracks (reproduced with permission of [45])

propagation without striations, but with intergranular cracks and voids formed around inclusions. Intergranular separation is typical of low cycle fatigue, as said in Sect. 1.4.2. Fatigue striations disappear also in high cycle fatigue during the early phase of macroscopic crack propagation at very low amplitudes close to the threshold stress intensity factor ΔK_{th} (see Figs. 10.22 and 10.23). Even though striations are characteristic of high cycle fatigue their observation on the fatigue fracture surface may not be so simple. This is the case of high strength materials having low deformation at fracture. These precipitation hardened metals are characterized by very small grains, 10–15 μm . They offer a thick grid of hard barriers to dislocations motion that are not allowed to extend and become so long to develop continuous arrays of ductile striations.

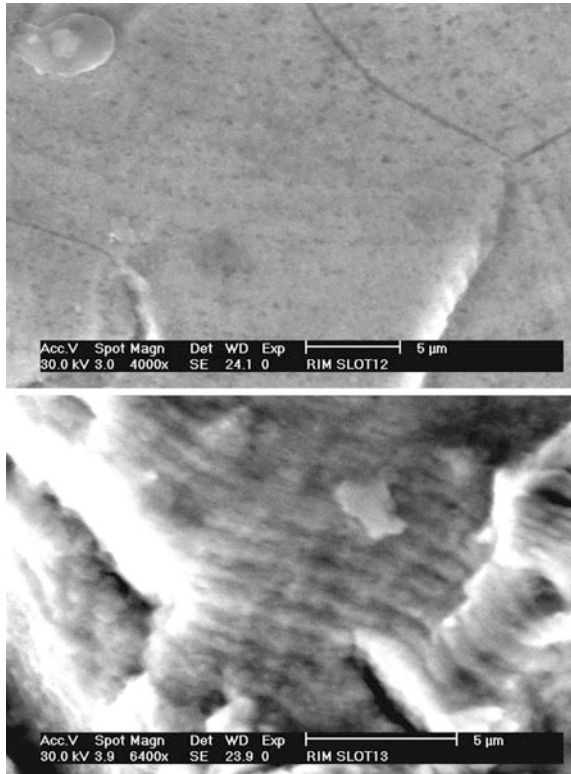
Fig. 2.45 SEM examination of the fracture surface of a waspaloy specimen fatigued at 500 °C **a** in vacuum and **b** after resting in air (Milella). Striations in vacuum are barely observed

fatigue in vacuum leaves very light signs of striations when it doesn't leave any at all. Figure 2.45 is an example of scanning electron microscope observations by Milella of fatigue striations on waspaloy at 500 °C in vacuum and air, respectively.

Fatigue tests were initially run in vacuum where striations are barely visible inside grains, Fig. 2.45a. Tests were interrupted to check specimens and then started again under vacuum. During these resting periods air was allowed to enter into the environmental chamber. The lesson learned from experience is that in such cases tests at restart show all signs of fatigue in air, growth rate included, even though they are run in high vacuum. This can be seen in Fig. 2.45b where striations appear after air has been admitted in the test chamber and test restarted, though in high vacuum. Striations spacing in vacuum seems to be larger than in air when it is well known that fatigue in vacuo cannot be more dangerous than in air.
