Chapter 2

Morphological Aspects of Fatigue Crack Formation and Growth

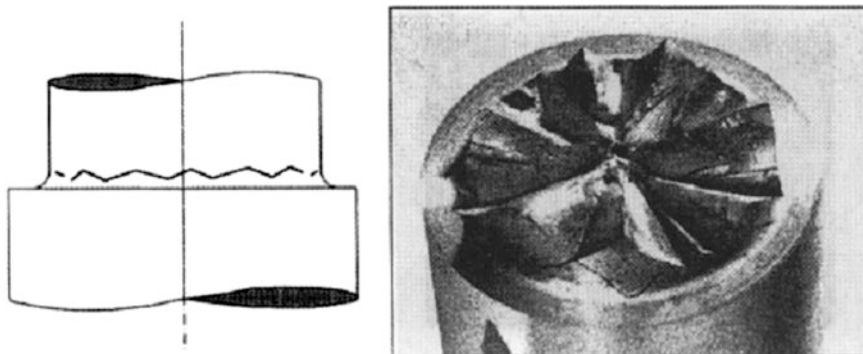
Fig. 2.46 Fatigue failure obtained under cyclic torsion in round carbon steel specimen (0.45 % C) with a fillet notch [50]. Note the characteristic factory roof type fracture surface

This apparent incongruence may be explained by saying that in vacuum each striation doesn't correspond to a single fatigue cycle since several cycles are needed to produce a single striation. Same result has been obtained on Ti-6Al-4 V [46, 47] by Pelloux and by Wadsworth and Hutchings on aluminum, copper and gold. They found that the ratio between life in air and under high vacuum (10^{-5} mm Hg $\sim 1.4 \cdot 10^{-4}$ atm) was about 1:20 for copper, 1:5 for aluminum and 1:1 for gold. This last result is particularly indicative since gold is very resistant not only to corrosion but also to simple oxidation. This actually confirms that in striations formation an environmental effect, namely surface oxidation, must take a role. It has been argued that in vacuum during the unloading phase and, in particular, during the load inversion a more or less complete re-fusion or healing of the sliding facets can take place because oxidation has not occurred. This delay when not stops at all the fatigue process. This is particularly true under very low amplitude stress when plastic slips are very limited and irreversible damage is very low. McClintoc and Pelloux [48] proposed a striation formation mechanism based on a surface oxidation process. Finally, it is useful to remember that no striation will appear if the crack is opened by a cyclic torque. Shearing stress does not produce striations. An example of macroscopic appearance of a carbon steel specimen broken under cyclic torque is presented in Fig. 2.46 [49].

The appearance is that of factory roof type. If one of those roofs were observed no sign at all of striations would appear at SEM analysis.
